**Activities in Guatemala  
In Support of the  
U.S. Hurricane Mitch Reconstruction Program**

**A Final Report Submitted to the  
U.S. Agency for International Development**

**U.S. Geological Survey**

**May 2002**

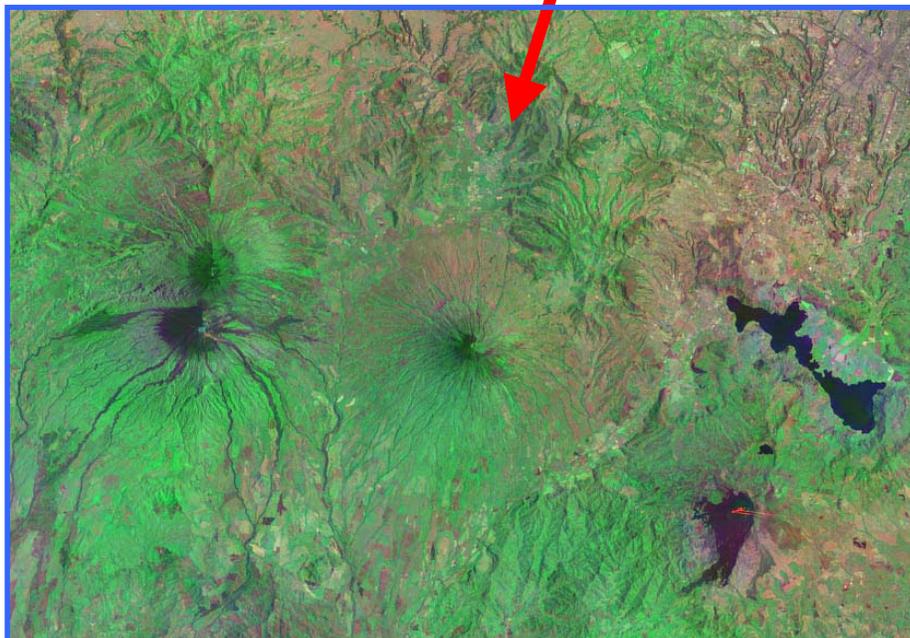
The sample Landsat image to the left shows Lago Amatitlan, and to the west, Volcan Agua and Volcan Fuego.

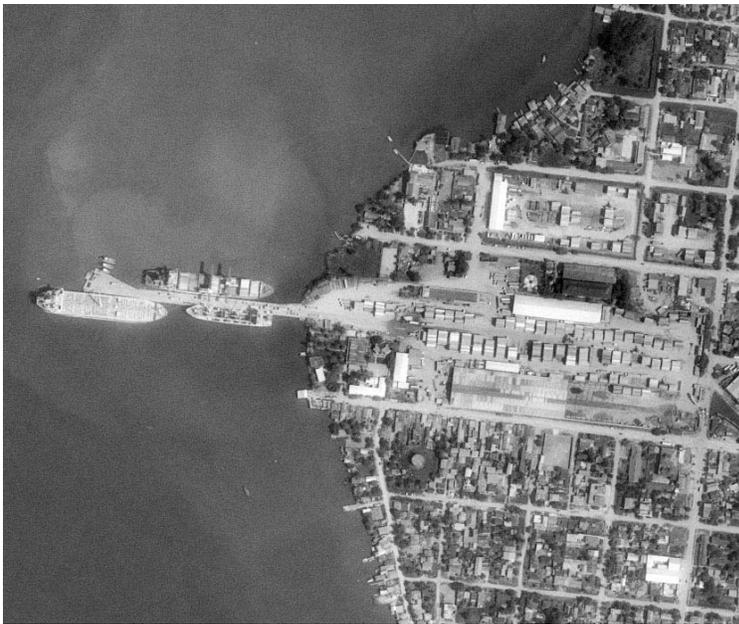
The figure to the left shows the port of Puerto Barrios, and Guatemala’s northern coast. Most of the aerial photography flown over Guatemala was flown at a scale of 1:40,000, however high-resolution scanning of negatives produces images with resolutions of 2-3 feet, equivalent to much larger scale photography.

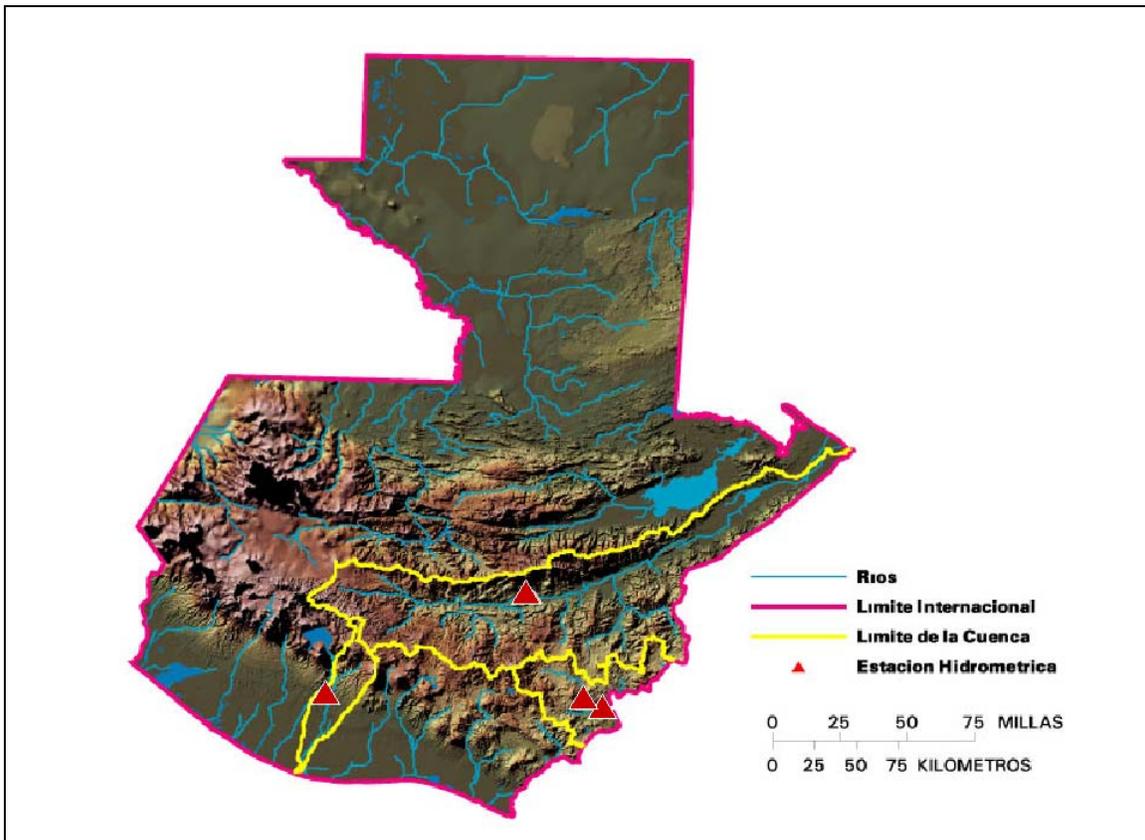
Figure 1. Hydrologic monitoring stations, each equipped with satellite telemetry, operational in Guatemala.

USGS and Guatemalan counterparts installed 2 state-of-the-art hydrologic monitoring stations in the Motagua and Coyolate River basins as part of the bilatera program and 2 monitoring stations in the Lempa River basin as part of the regional program (fig. 1). Ongoing monitoring and management of water resources in these river basins are deemed critical to the safety and economic well-being of the country.

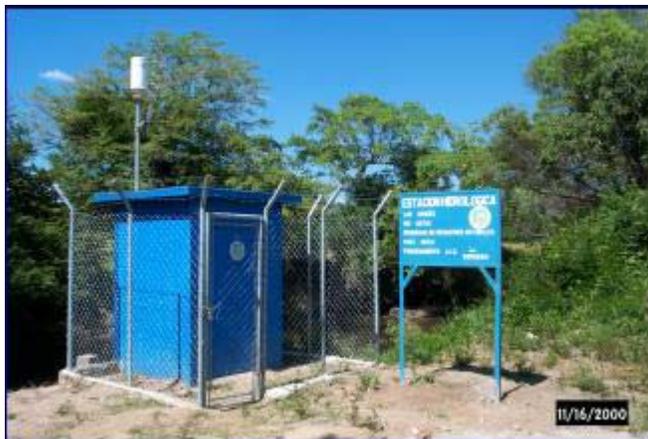
Figure 2. Streamflow monitoring station Río Ostúa at Las Cruces.

Real-time transmission of data from hydrologic monitoring stations is new to Guatemala – the technology implemented in Guatemala is the same as that used by the USGS in the United States. Each station transmits hydrologic data via satellite, which is received in real-time by downlink stations in Guatemala and Puerto Rico. There are two modes of operation: 1) normal mode, in which hydrologic data collected every 15 minutes are transmitted via satellite at 3-hour intervals; and 2) emergency mode, in which hydrologic data are transmitted as frequently as every 5 minutes during periods of flooding or heavy rainfall. An example of the streamflow gaging stations installed as part of the USGS program in Guatemala is shown in Figure 2.

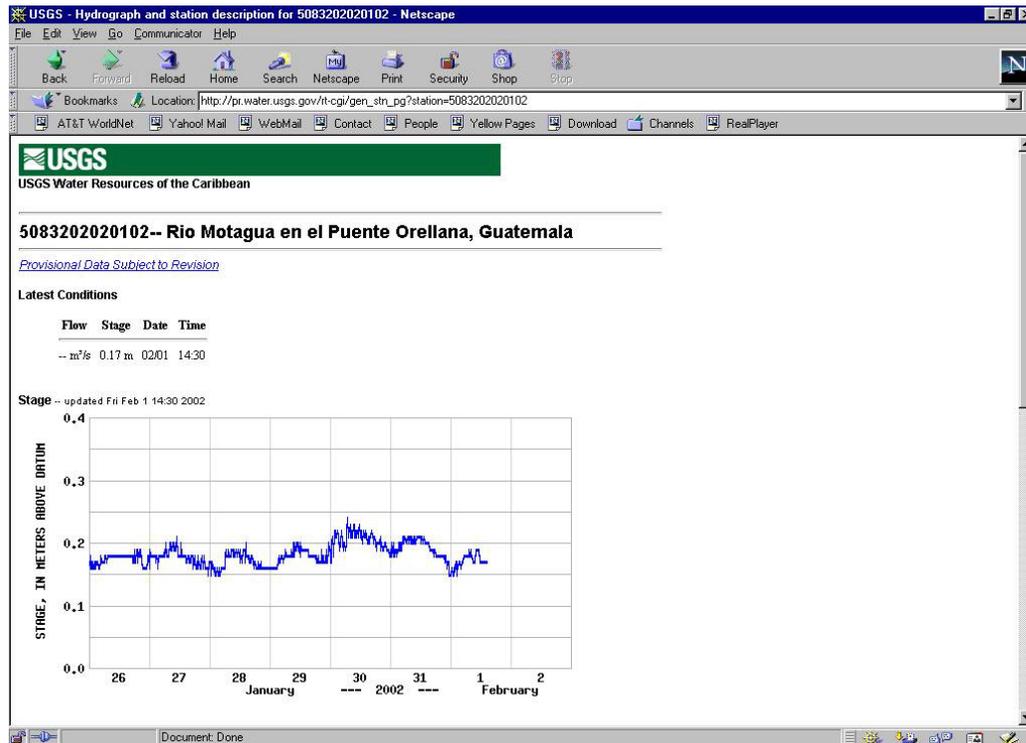
Figure 3. Graphical display of river stage for the Río Motagua at the Orellana Bridge, Guatemala.

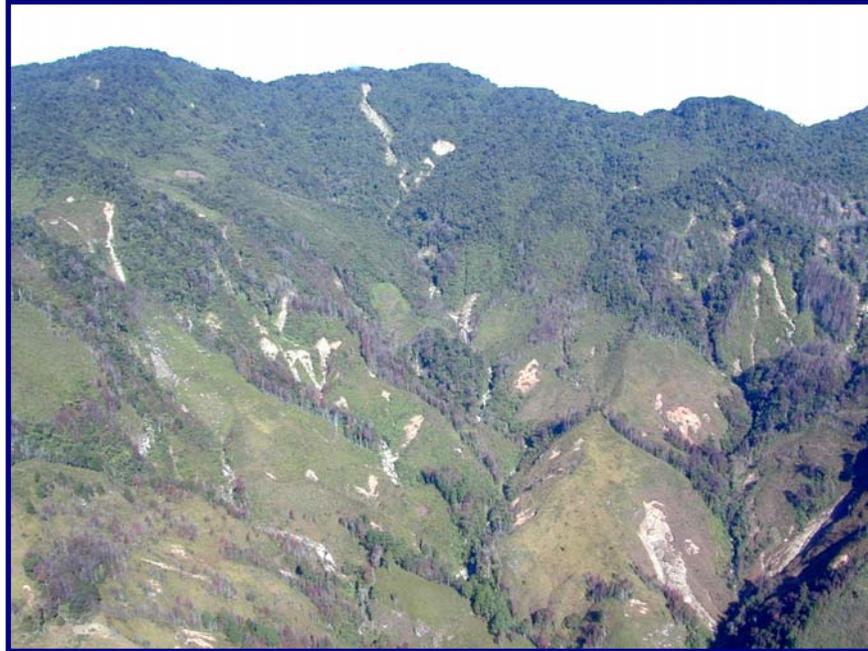
Figure 1. Landslides typical of the central part of the Sierra de las Minas, eastern Guatemala.

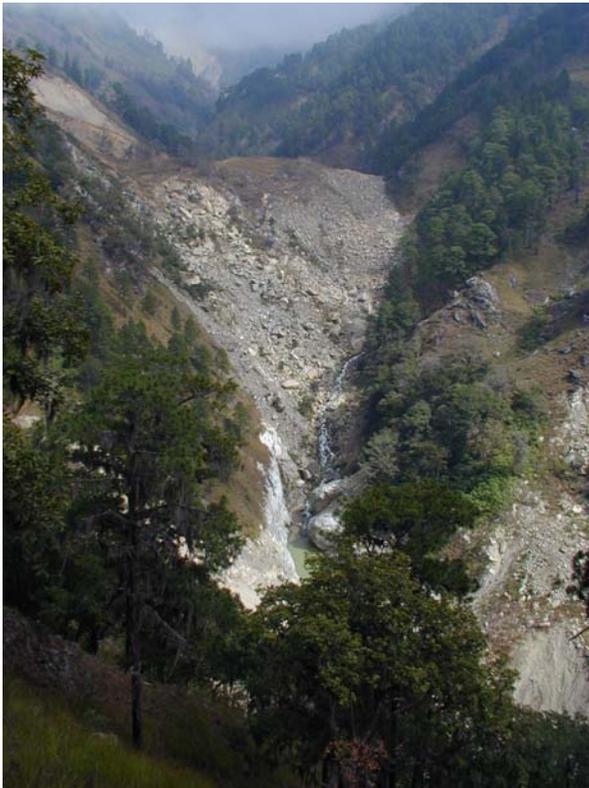
Figure 2. Landslide dam on the Río La Lima, looking upstream (north) from a point 4 km north (upstream) of the town of Jones; photograph taken 25 January 2000. The landslide originated on the steep slope in the upper left corner of the photograph. The point of discharge of the river from the debris that forms the dam is at the point where the water is first visible at the middle right part of the photograph.

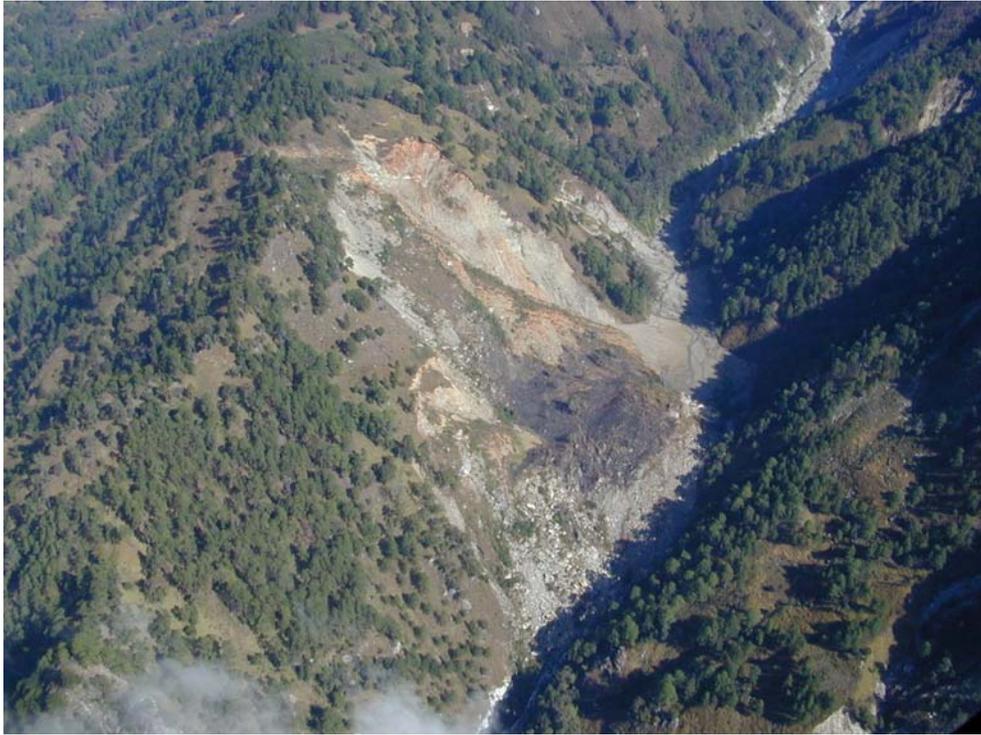
Figure 3. Oblique aerial view to north of the landslide that produced the dam on the Río La Lima; photograph taken 12 January 2001. Smooth even-toned surface crossed by Río La Lima at the toe of the landslide is the sediment fill behind the landslide dam.

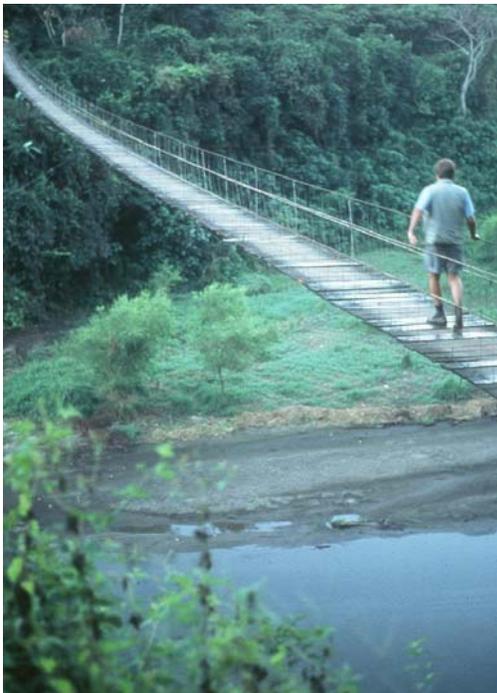
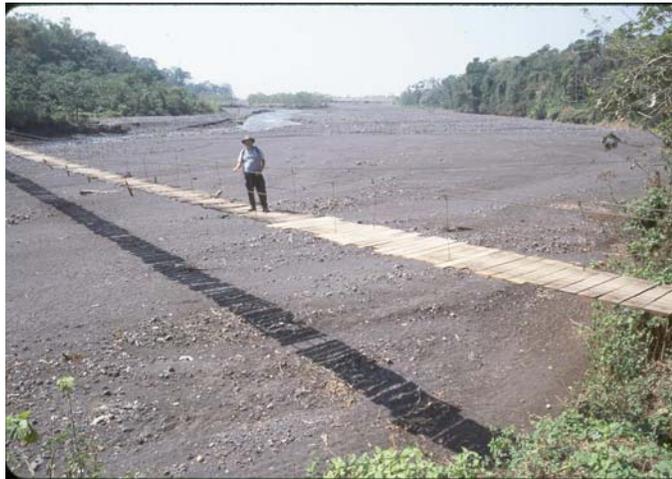
**Figures 1&2 - Bridge near San Filipe before (left) and after (above) sedimentation from lahars (volcanic debris flows). The difference in base level of the river bed is about 25 meters.**

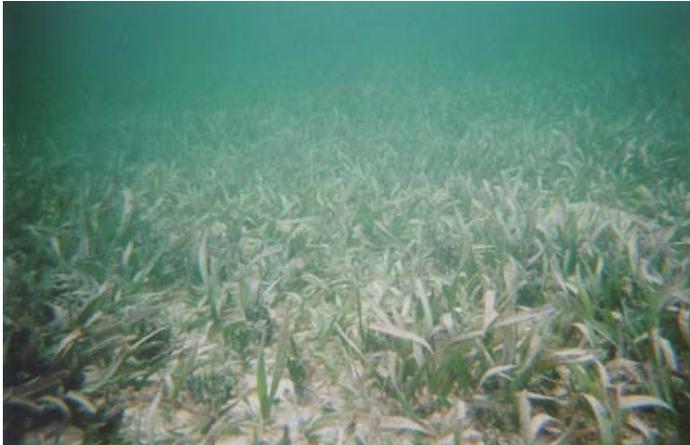
*Thalassia testudinum* ca. 70 m from shoreline of western Punta de Manabique, Guatemala; depth ca. 2 m. The substrate is sandy and appears to be accreting in much of the area. *Thalassia* forms sparse colonies here, and appears to be partly covered with accreting substrate.

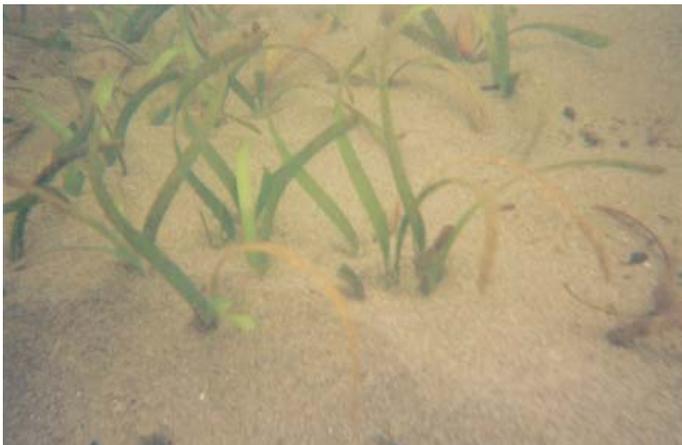
*Thalassia testudinum* ca. 20 m from shoreline of East End, Cayo Grande, Cayos Cochinos, Honduras; depth ca. 1 m. Substrate is rocky with shell fragments and other pulverized calcium carbonate skeletons. *Thalassia* forms moderately dense colonies, growing in

porous substrates among coral rocks.
