**Activities in Honduras
In Support of the
Hurricane Mitch
Reconstruction Program**

**A Final Report Submitted to
The U.S. Agency for International Development**

U.S. Geological Survey

May 2002

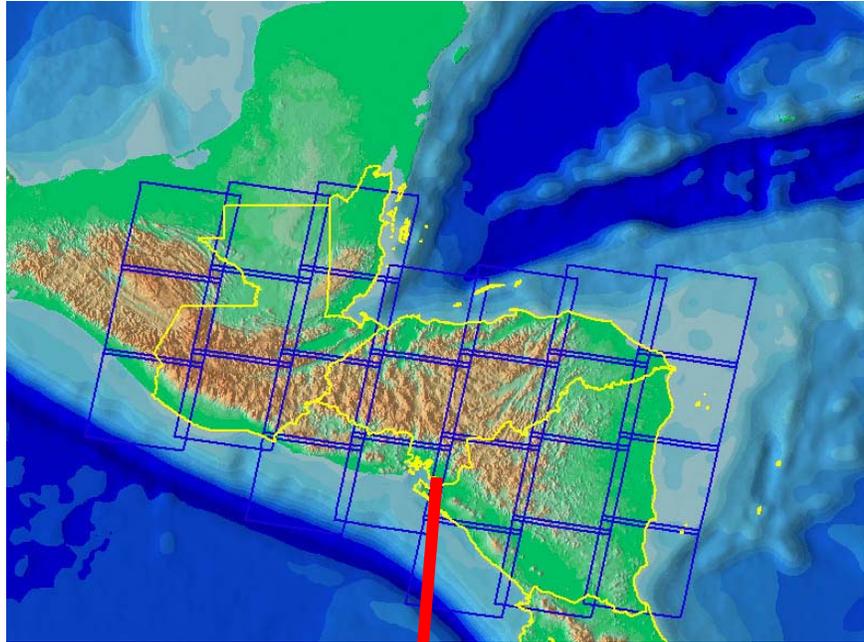
Landsat satellite imagery provides 15-30 meter resolution and the ability to detect subtle differences in vegetation and land cover. The figure to the right shows the location of individual Landsat images (scenes) covering the Mitch-affected countries. The USGS compiled and mozaicked complete Landsat satellite imagery coverage for El Salvador, Belize, Honduras, El Salvador, and Nicaragua, both in digital form on CD-ROM, and as large format prints.

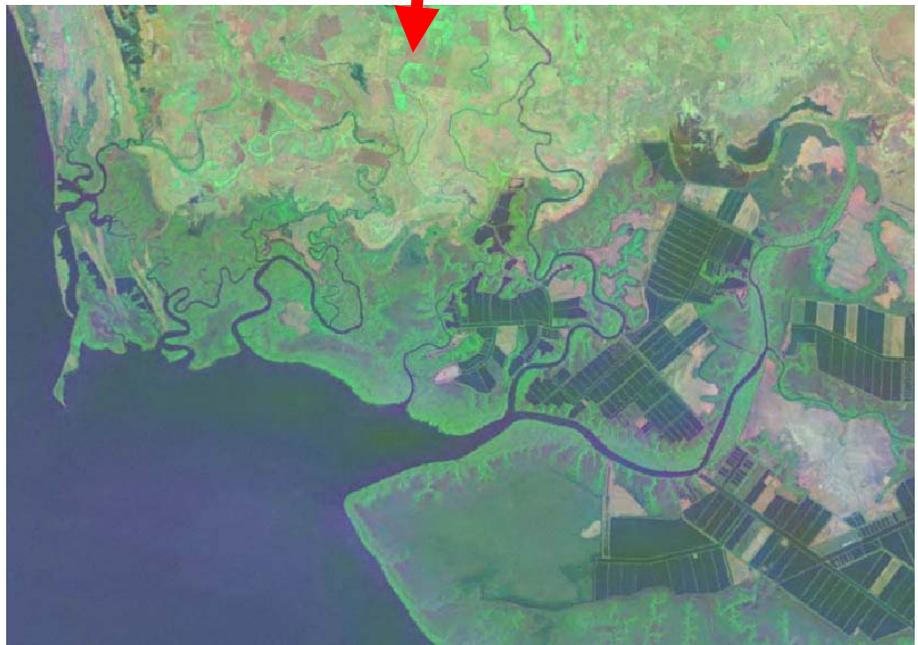
The sample Landsat image to the right shows mangroves, shrimp farms, and cultivated areas bordering the Gulf of Fonseca on the Pacific Coast of Honduras. Landsat mage products were provided to U.S. and Honduran counterpart agencies participating in USAID-funded Hurricane Mitch relief activities, and are also now available to the

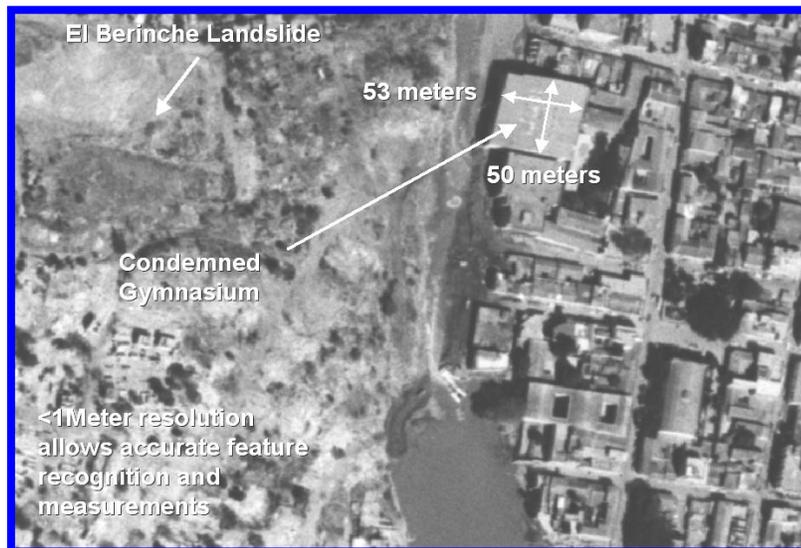
The aerial photo to the right shows the dramatic effects of the El Berinche landslide in Tegucigalpa. The landslide, which was triggered by the torrential rains during Mitch, effectively dammed the Choluteca River. Since Tegucigalpa has no advanced sewage treatment, this event caused a serious and immediate health hazard. Photography like this was used in initial assessments of landslides and flooding throughout Honduras.

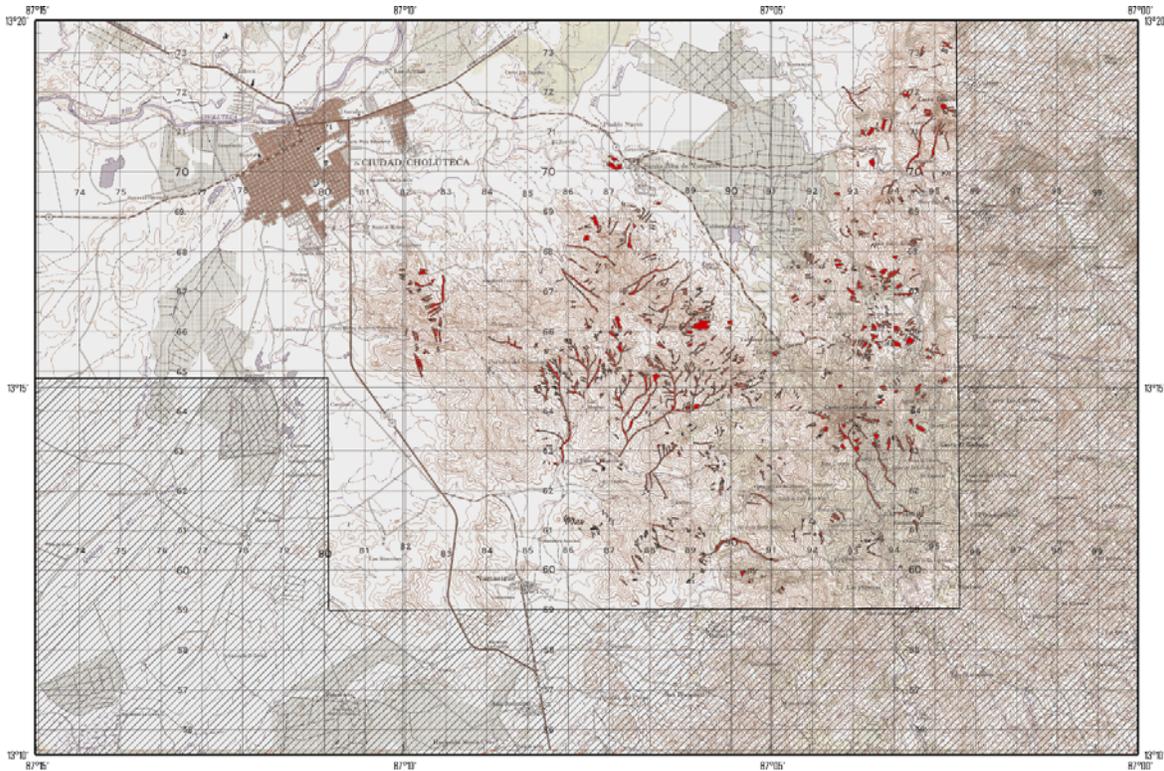
Figure 1. Landslide inventory map of the Choluteca area in southern Honduras.

U. S. Geological Survey Open-File Report #02-061 describes the landslide occurrence throughout the country of Honduras as a result of Hurricane Mitch and documents the types, sizes, and distribution of landslides in those areas of Honduras where there were high concentrations of landslides and where an ongoing landslide hazard exists. For those portions of the country where the landslides contribute a significant part of the sediment that is being transported within the stream and river network, estimates of sediment volume due to landslides are tabulated. A typical landslide inventory map is shown in figure 1.

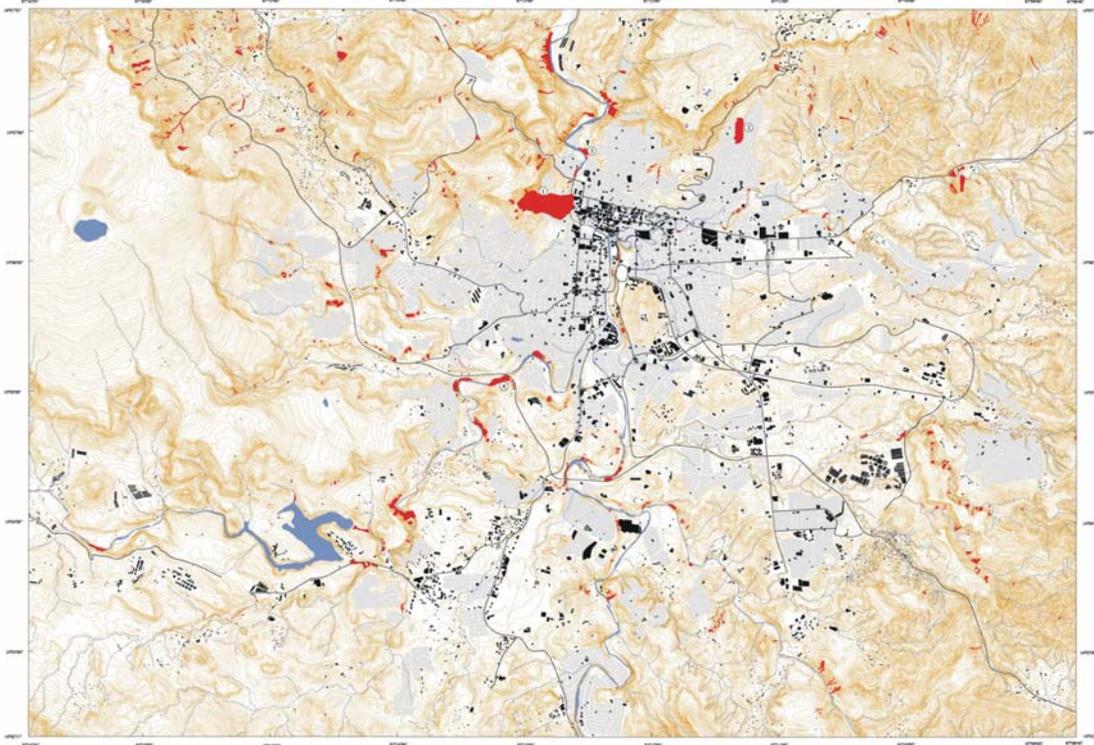
Figure 2. Inventory map of landslides triggered by Hurricane Mitch in Tegucigalpa, Honduras. Red polygons are landslides triggered by the hurricane.

The distribution of landslides that occurred in the metropolitan area of Tegucigalpa was documented through the use of aerial photography taken by the U. S. Air Force at a scale of 1:40,000 and additional aerial photography at a scale of 1:20,000 taken by a local contractor. The inventory was initially mapped onto 1:10,000-scale topographic maps of the city produced by the Instituto Geografico Nacional. The final landslide inventory is displayed on a mosaic of these base maps at a scale of 1:15,000. The accompanying report (USGS Open-File Report 02-33, figure 2) describes the landslides, their distribution, the various landslide processes at work during their occurrence, and the four largest landslides that produced the greatest impact on people and property.

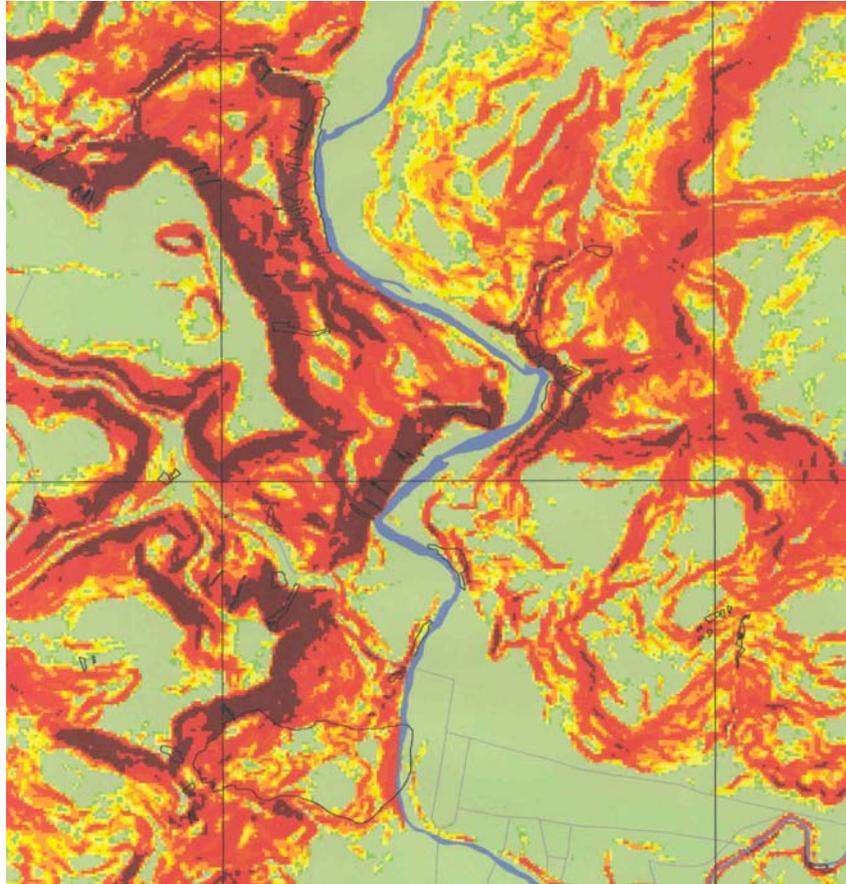
Figure 3. Example of landslide hazard map of Tegucigalpa. Red=high hazard, orange=moderately high hazard, yellow=moderate hazard, and green=low hazard. Outlined polygons are landslides triggered by Hurricane Mitch.

With the landslide inventory map of Tegucigalpa to use as comparison, we have constructed a landslide hazard map of the capitol city. We have estimated the shear strengths of all of the geologic units using the recent geologic map made of the Tegucigalpa area by the Japanese International Cooperative Agency, we have prepared a slope map from the recent contour map made by this same agency, and we have used these data as input into an infinite slope analysis that calculates the factor of safety for every slope cell on the map. The resulting map is a factor-of-safety map, referred to as a susceptibility map. Comparing this map to the actual landslides triggered by Hurricane Mitch, we have constructed a probabilistic landslide hazard map for the Tegucigalpa area. This map (figure 3) estimates the landslide hazards for the occurrence of debris flows triggered by an extreme event such as Hurricane Mitch. However, even for a lesser event, the relative hazard from debris flows will be the same as the probability density function that relates factor of safety to landslide occurrence will be of the same form.

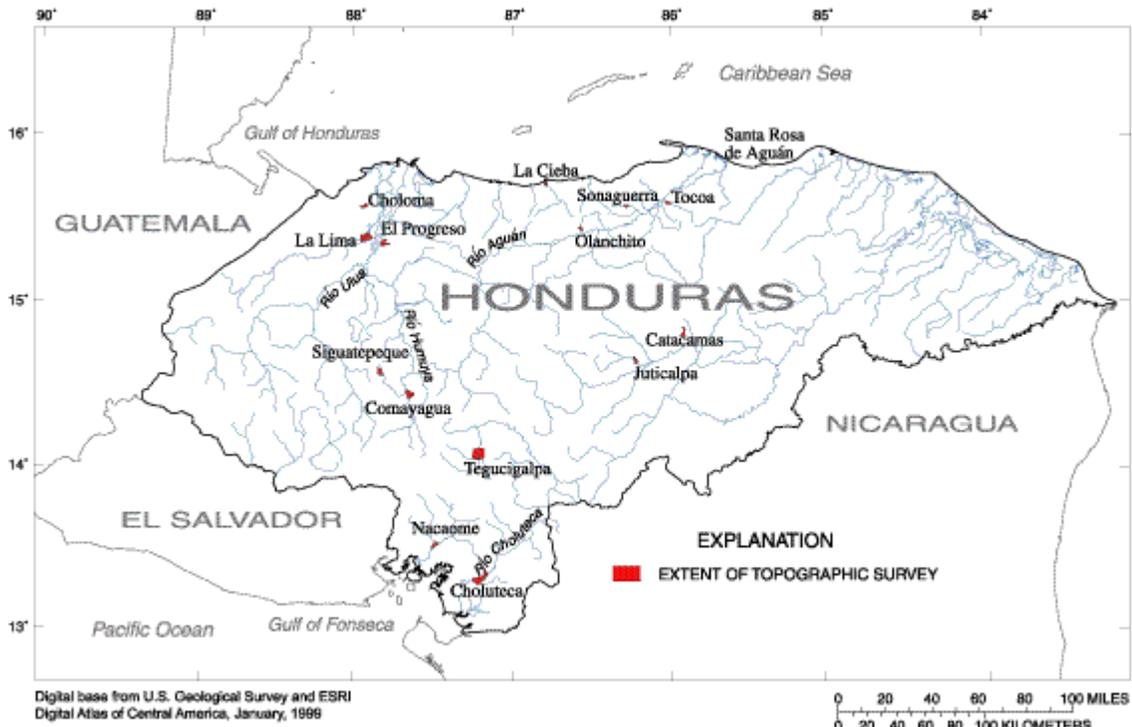
Figure 1. Flood-hazard areas mapped by airborne topographic surveys, Honduras.

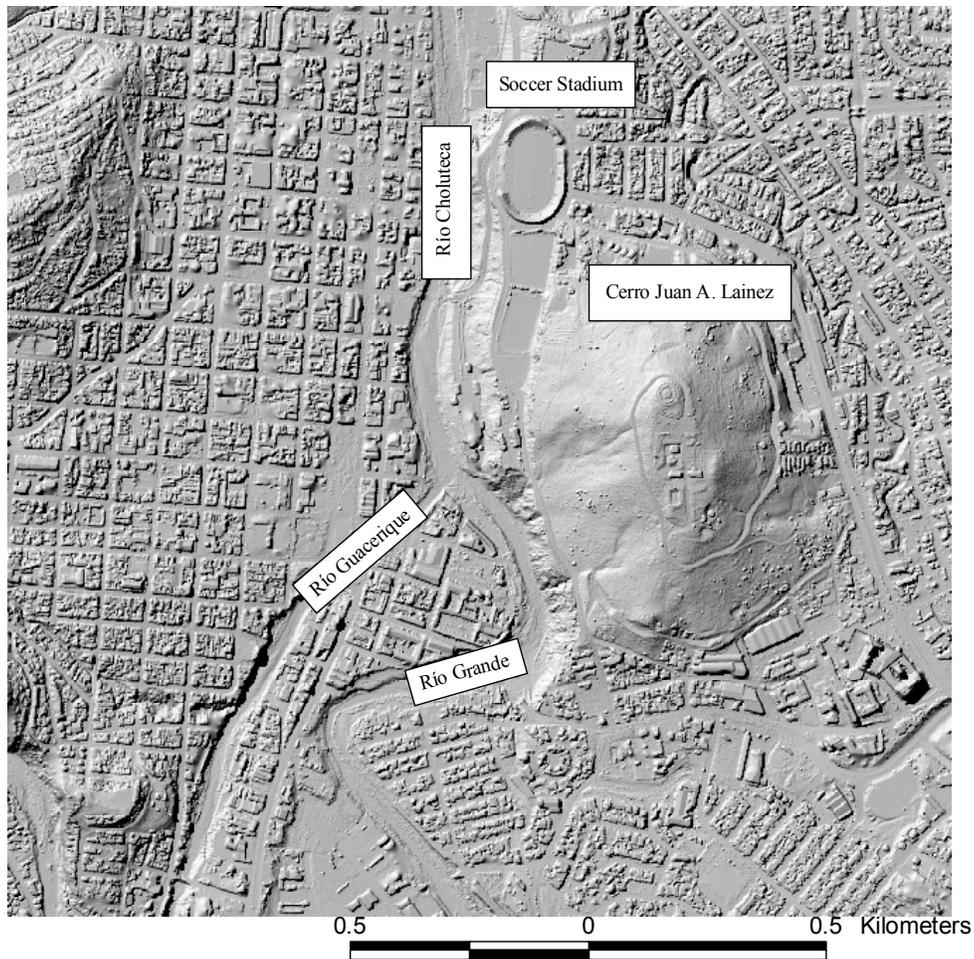
Figure 2. Shaded relief image in Tegucigalpa, Honduras of the LIDAR DEM filtered to remove vegetation.

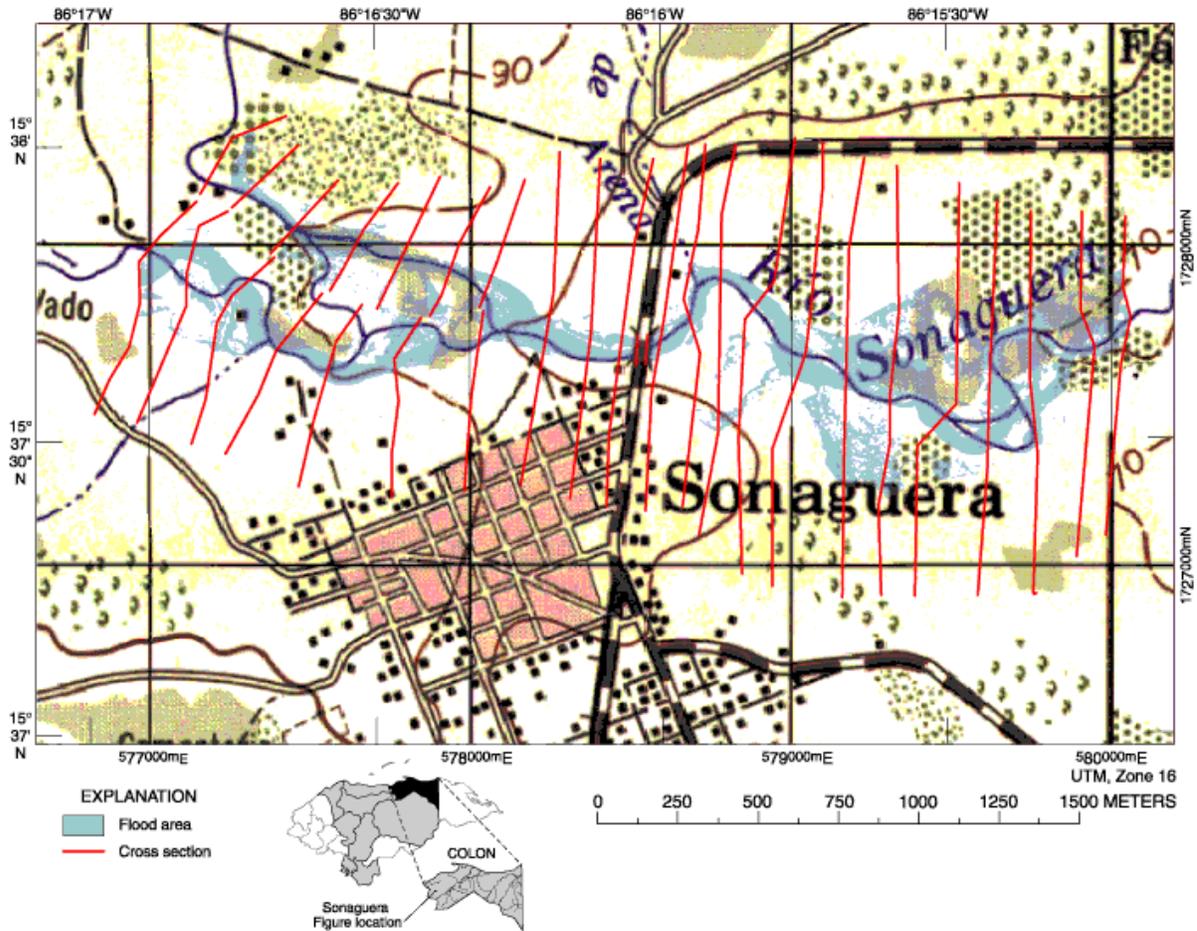
Figure 3. Extent of inundation for the 50-year flood and location of cross sections at Sonaguera, Honduras

The primary products from this project are the flood-hazard maps (fig. 3 and 4). These are presented formally in the site reports. However, to support the concurrent Municipal GIS project and provide users of the products flexibility in viewing the products, the cross section location, area of inundation, and depth of flooding used for the flood-hazard maps were compiled as GIS shapefiles for each of the 15 municipalities. These shapefiles allow users with a GIS such as ArcView to view the areas in detail and overlay them over other GIS themes. The Municipal GIS project is supplying municipalities with ArcView software and training and the flood-hazard shapefiles. Also, as an aid to similar, future projects, a shapefile was developed that estimates the 50-year-flood

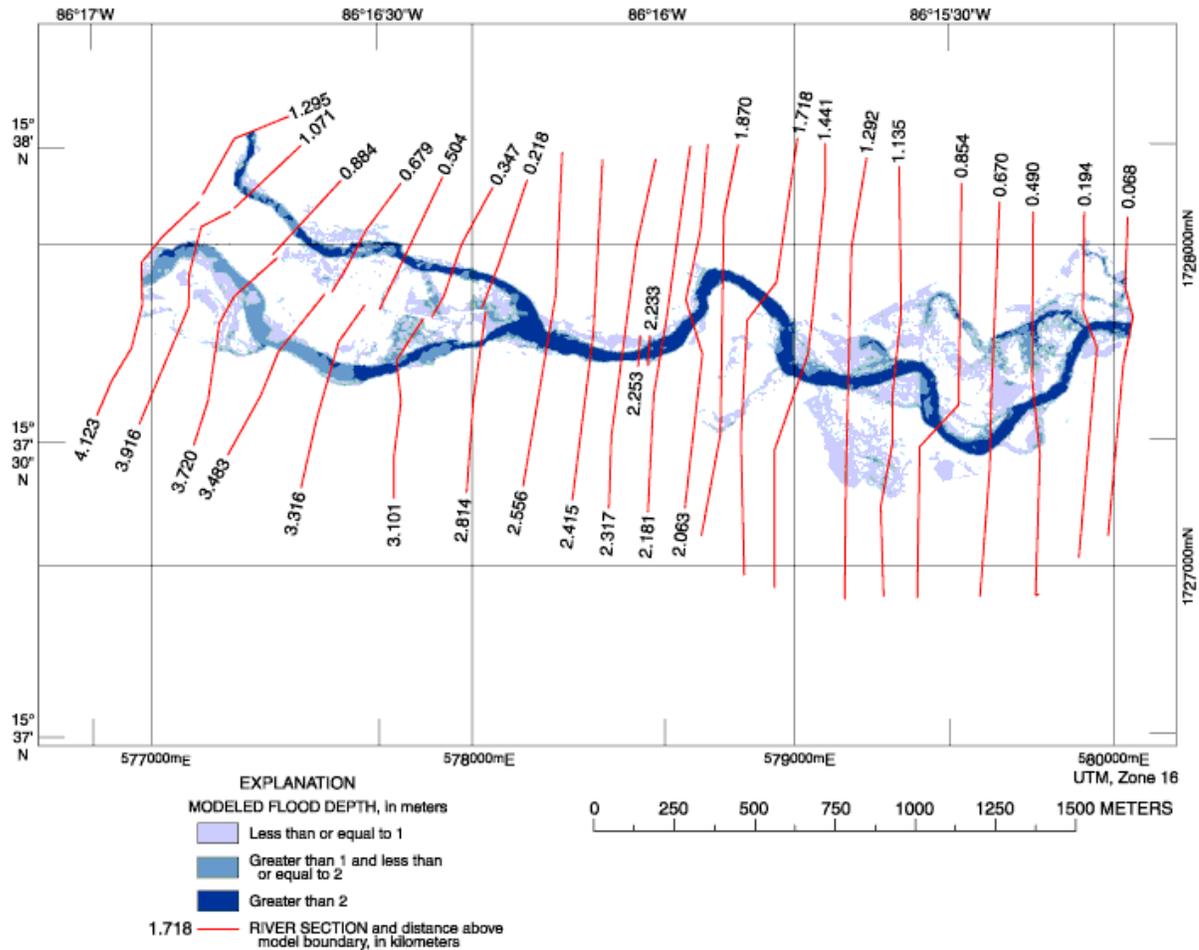
Figure 4. Depth of inundation for the 50-year flood and location of cross sections at Sonaguera, Honduras.

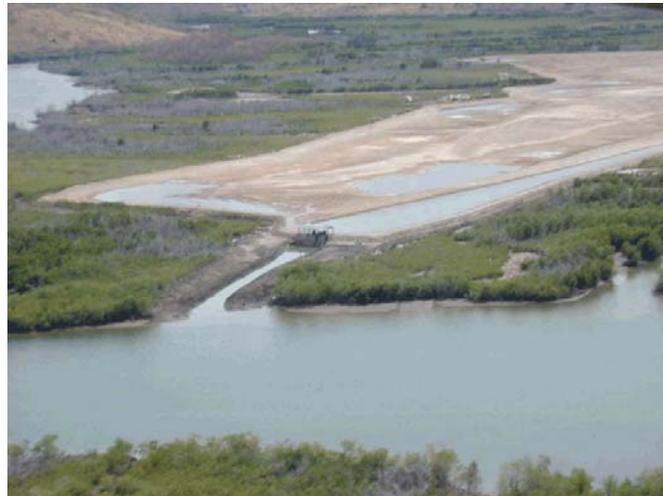
Figure 2. Aerial photograph of shrimp farm and mangrove shoreline in the Gulf of Fonseca taken from the USGS amphibious airplane (T. Michot, Pilot).

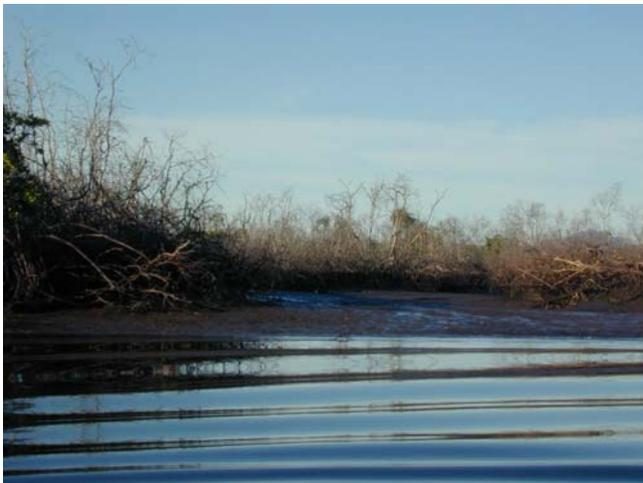
Figure 3. Mangrove shoreline in the Gulf of Fonseca showing severe damage from flooding and sedimentation resulting from Hurricane Mitch.

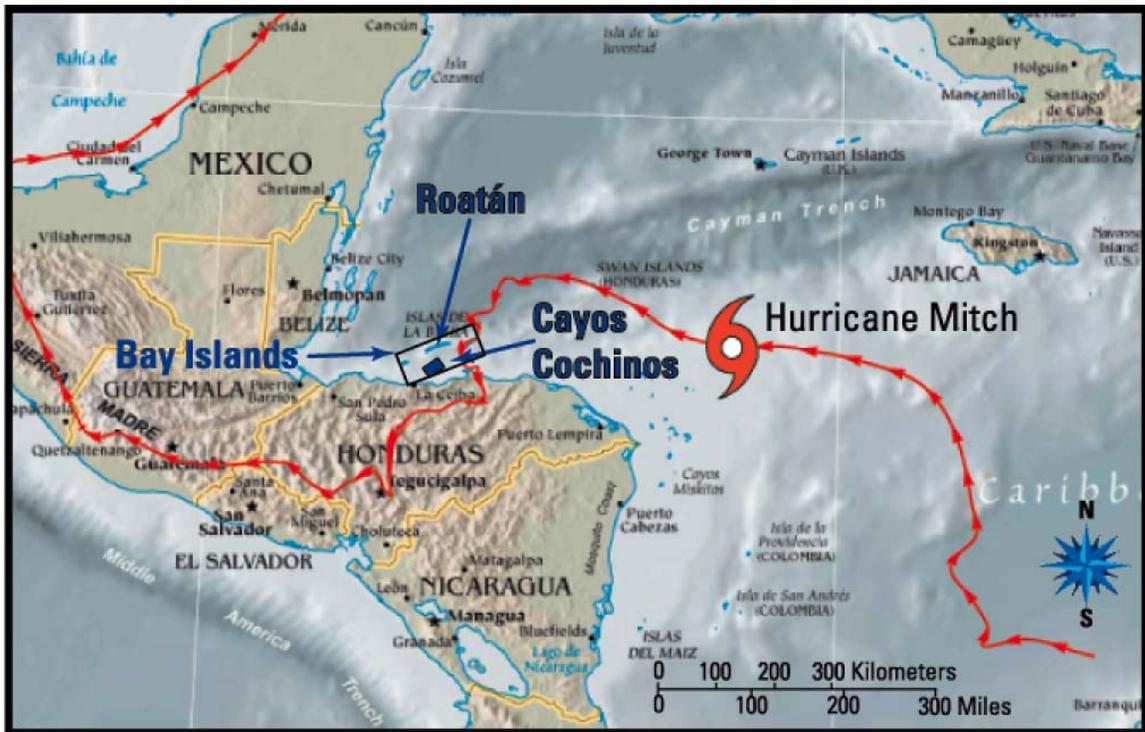
Figure 2. Index map showing location of Cayos Cochinos and Roatán, Honduras and the path of Hurricane Mitch in October 1998.

Mitch lost energy and became a category 4 hurricane on October 27 as it began to interact with the mountains on the Honduras mainland. Mitch passed over Roatan, Guanaja, and Cayos Cochinos on October 27 & 28 (Figure 2) with 130-mph winds that caused severe damage to buildings and onshore habitats. Mitch dropped over 6 ft of rain on the mainland causing severe flooding, landslides, and mudflows. In response to this devastation, the U.S. Geological Survey (USGS) received supplemental congressional funds through the U.S. Agency for International Development (USAID) to establish a network of early detection systems (stream gages, maps of landslide-prone areas, etc), assess impacts to potable water quality, and assess damage to coastal resources such as coral reefs, sea grass beds, and mangrove forests. This study focused on the impacts that Mitch had on the coral reef ecosystems of Cayos Cochinos and Roatan, Honduras.

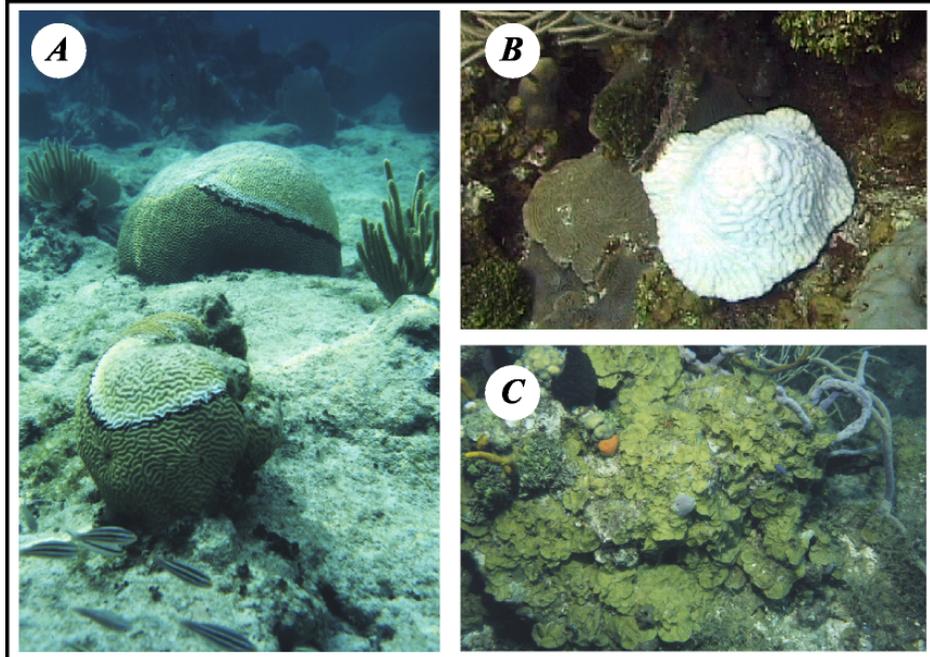
Figure 3. Photographs of (A) Black Band Disease on brain coral (*Diploria* sp.), (B) bleached *Meandrina* sp. coral, and (C) typical algae (*Lobophora* sp.) overgrowth along the reef crest.

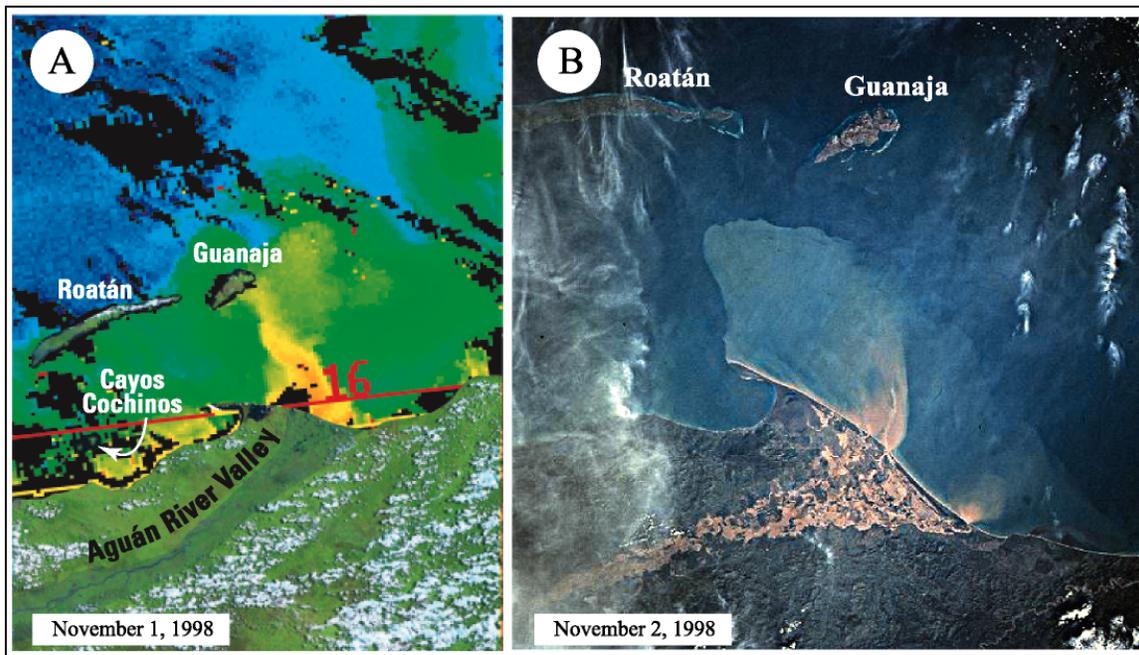
Figure 4. (A) Color-enhanced satellite image (SeaWiFS) and (B) NASA Space Shuttle photograph (STS-095-711-71) showing the extent of the fresh water plume as a result of the intense rainfall produced by Hurricane Mitch. SeaWiFS image courtesy of ORBIMAGE and the University of South Florida. Space Shuttle photograph courtesy of NASA Earth Sciences and Image Analysis, Johnson Space Center.

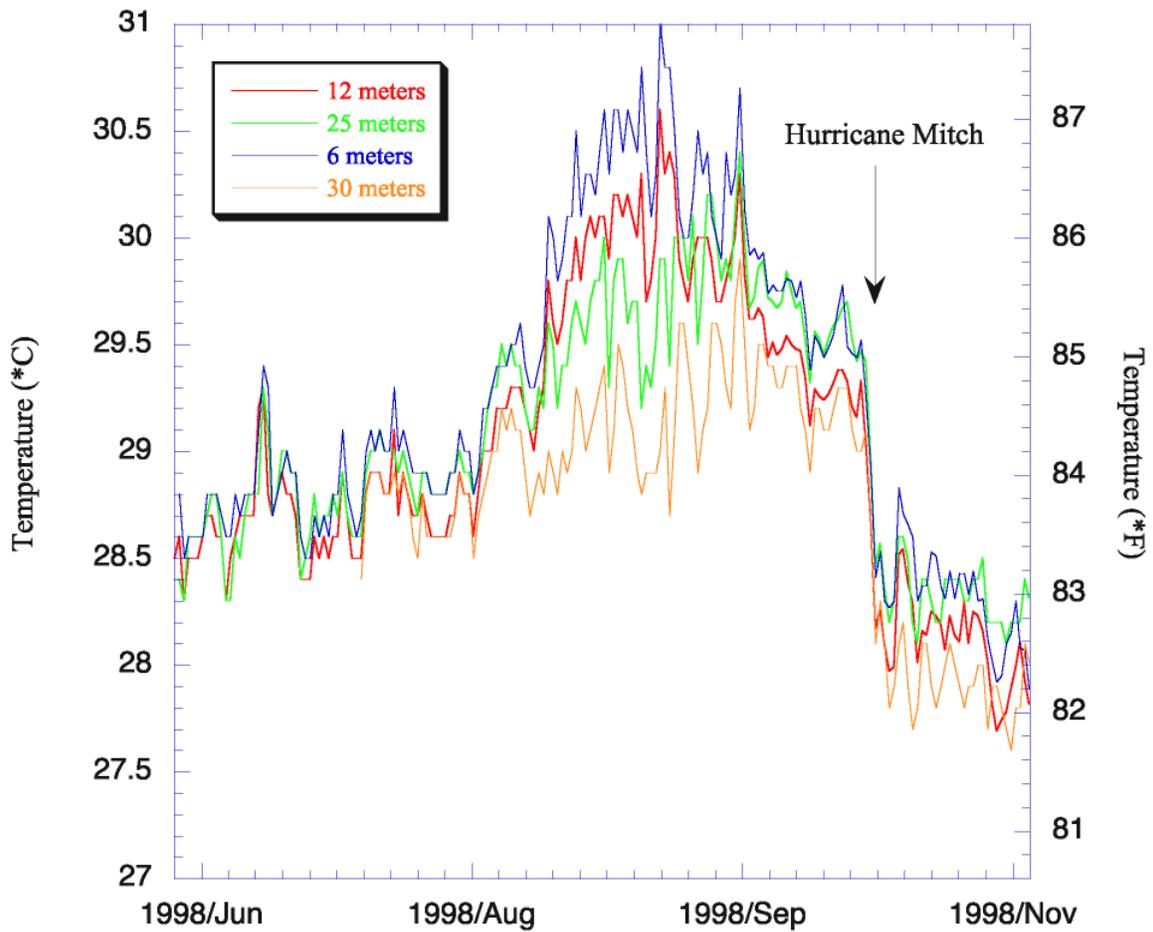
Figure 5. Temperature record at various depths on Pillar Coral Reef located off Sandy Bay, Roatan. It is apparent that Hurricane Mitch had an overwhelming affect on lowering sea surface temperatures at this site. This graph also shows the temporal extent of the high sea surface temperatures that lead to mass mortality of corals throughout the Caribbean from coral bleaching.

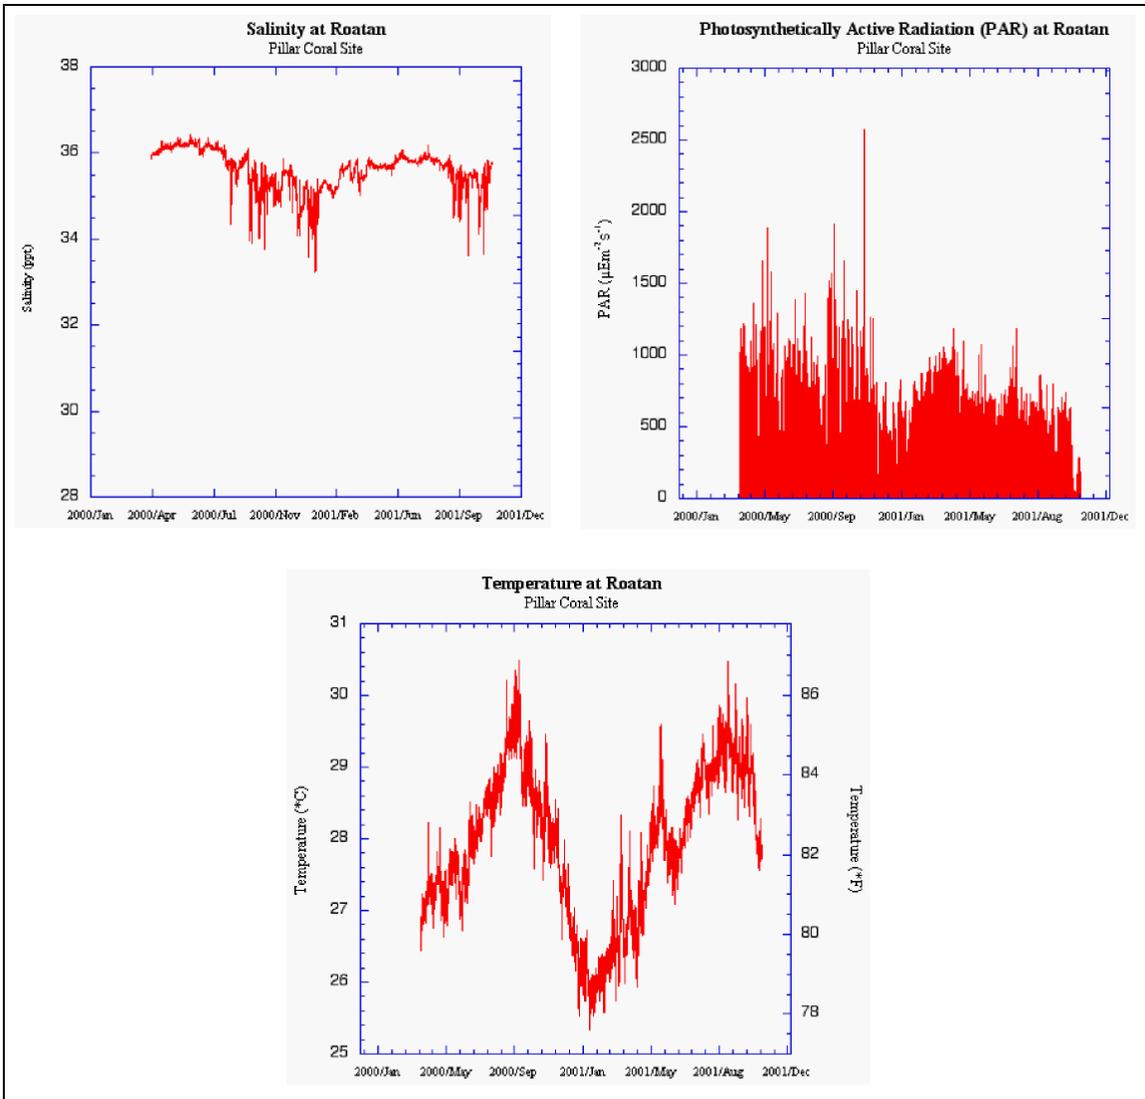
Figure 6. Data collected by SeaBird electronic instrument moored in 17 feet of water at Pillar Coral Site located off Sandy Bay, Roatán.

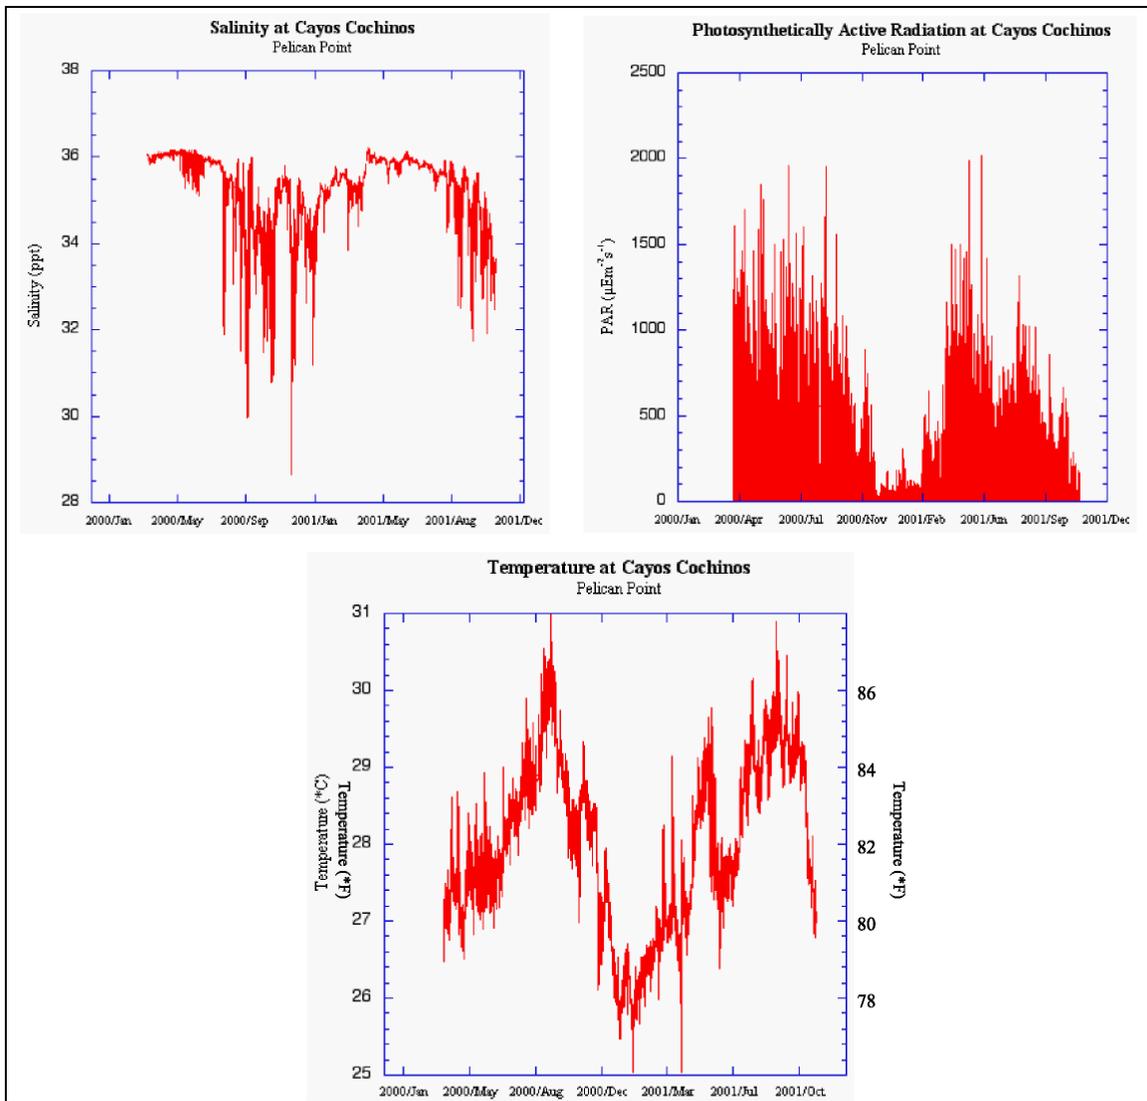
Figure 7. Data collected by SeaBird electronic instrument moored in 17 feet of water at Pelican Point located off Cayos Cochinos Grande.

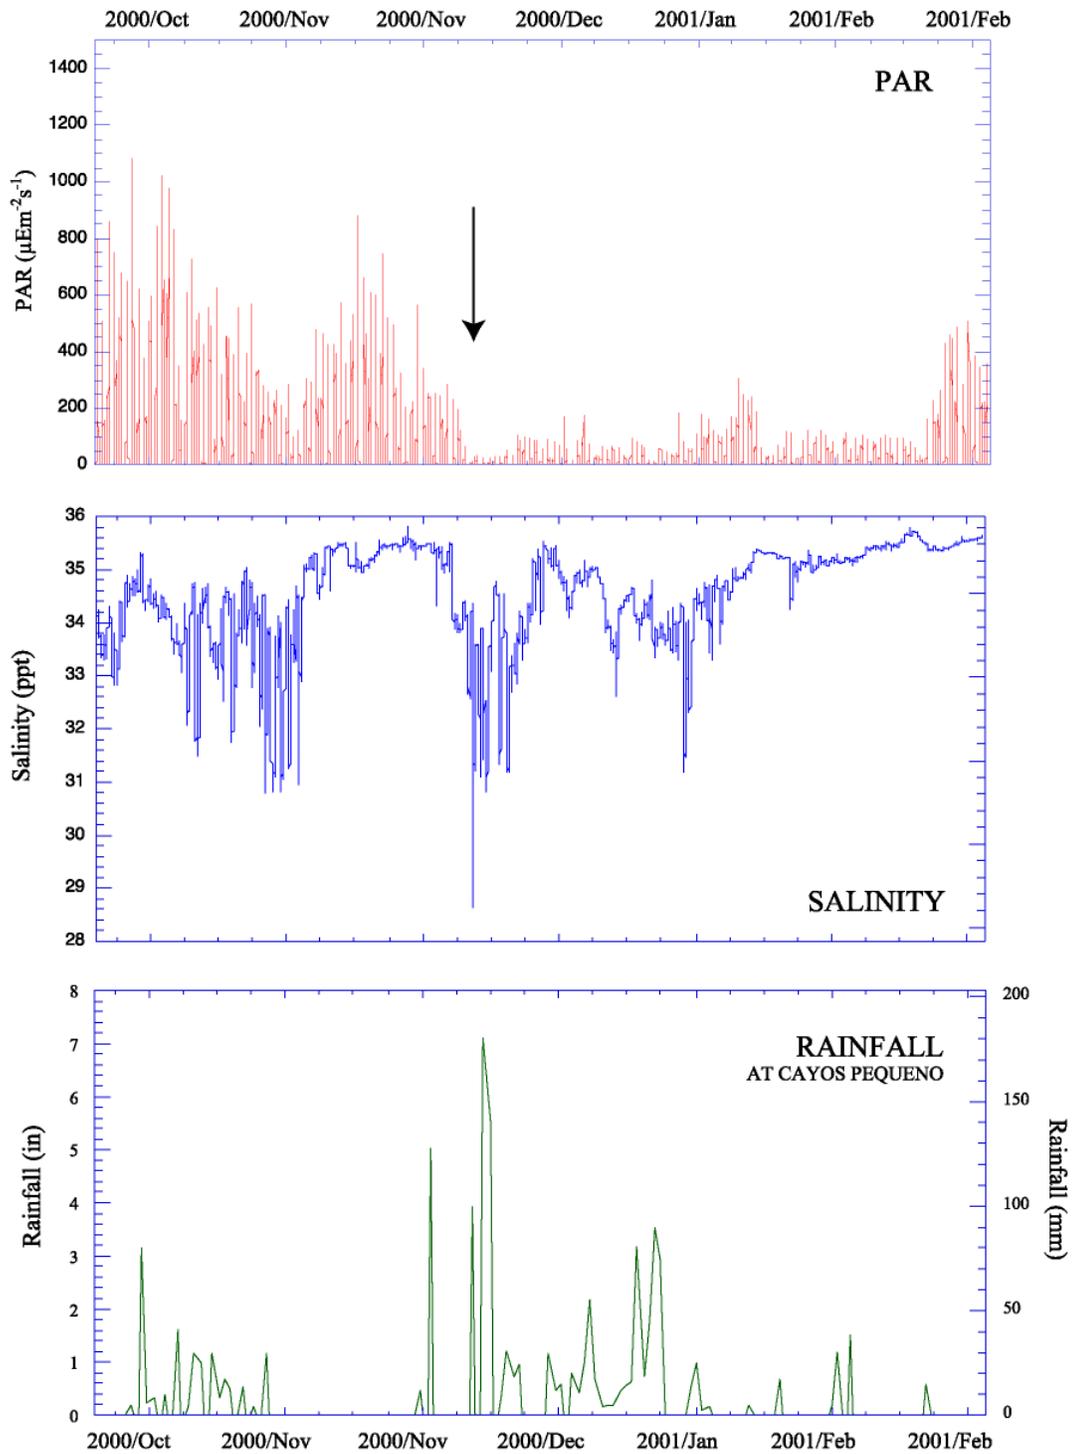
Figure 8. Data from Cayos Cochinos showing the relationship between Rainfall, Salinity and Photosynthetically Active Radiation (PAR). Local rainfall events, in addition to fresh water inputs from the mainland, can be detected in the salinity and PAR data as shown here. Typically, rainfall increases particulate material (sediments) in the seawater thereby decreasing the clarity and hence the light penetration.

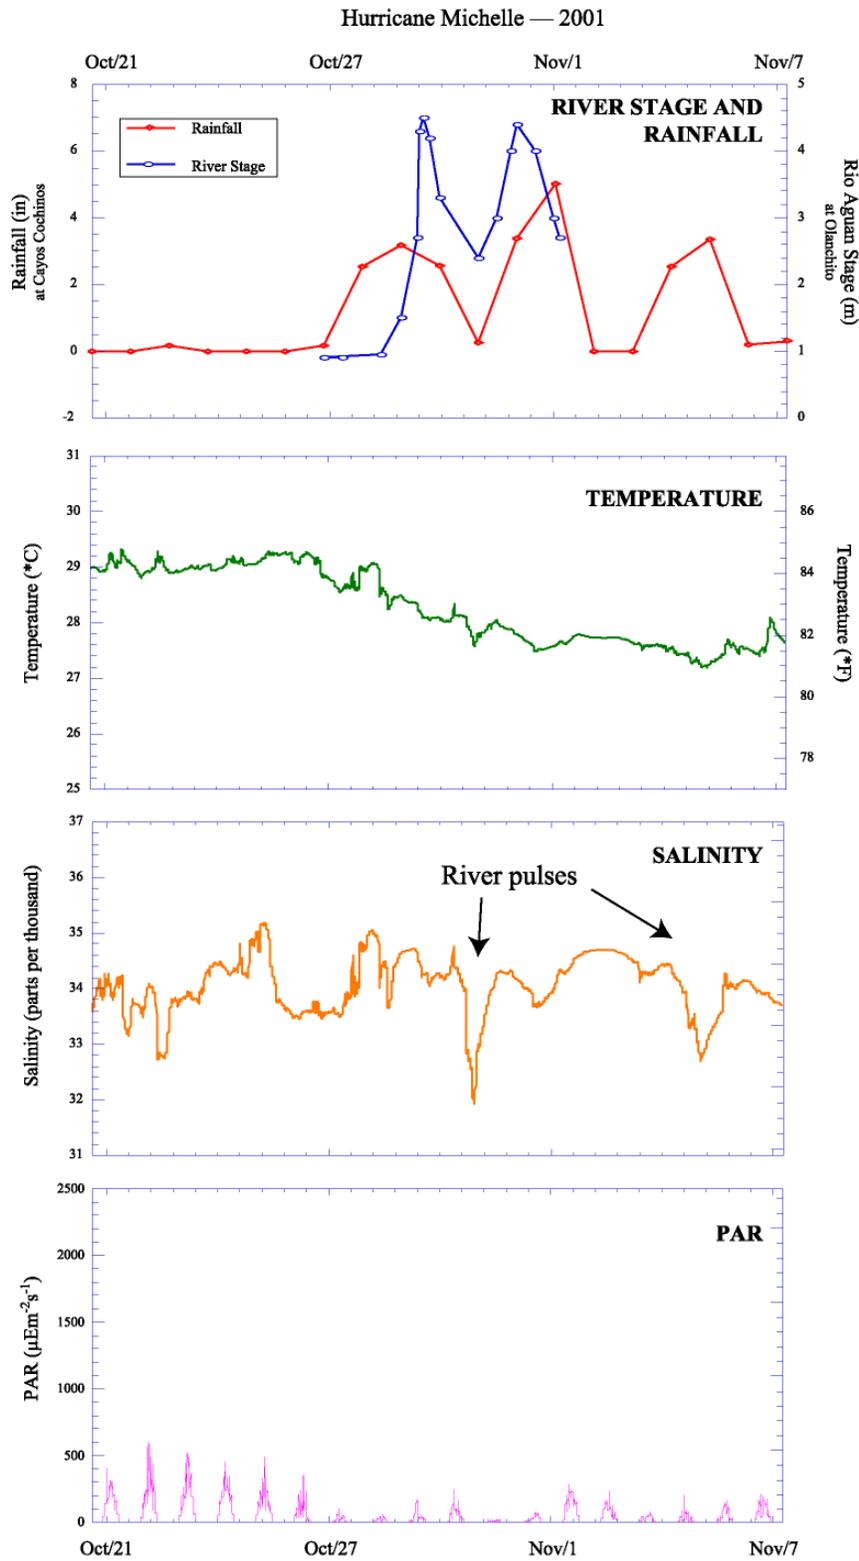
Figure 9. Data collected at Cayos Cochinos during the fall of 2001 when Hurricane Michelle was heavily raining on the Honduras mainland. Sea surface temperatures began to drop as a result of the rainfall and the salinity record shows two sharp decreases that can be correlated to the two pulses recorded on the Rio Aguan at Olanchito.

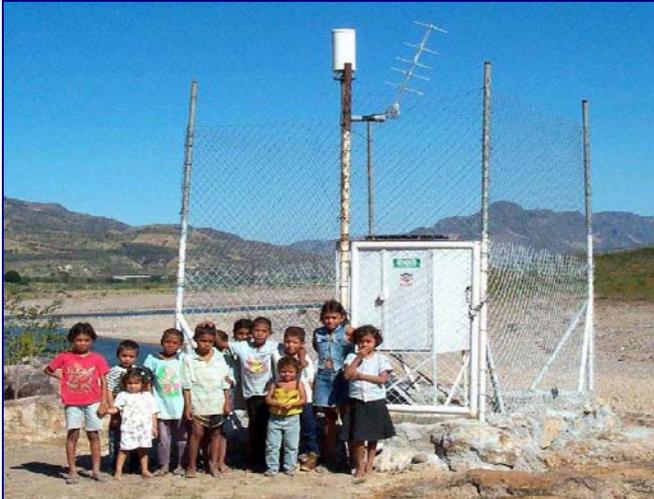
Figure 2. Streamflow monitoring station Río Choluteca at Colonia Apacilagua, installed in May 1999.

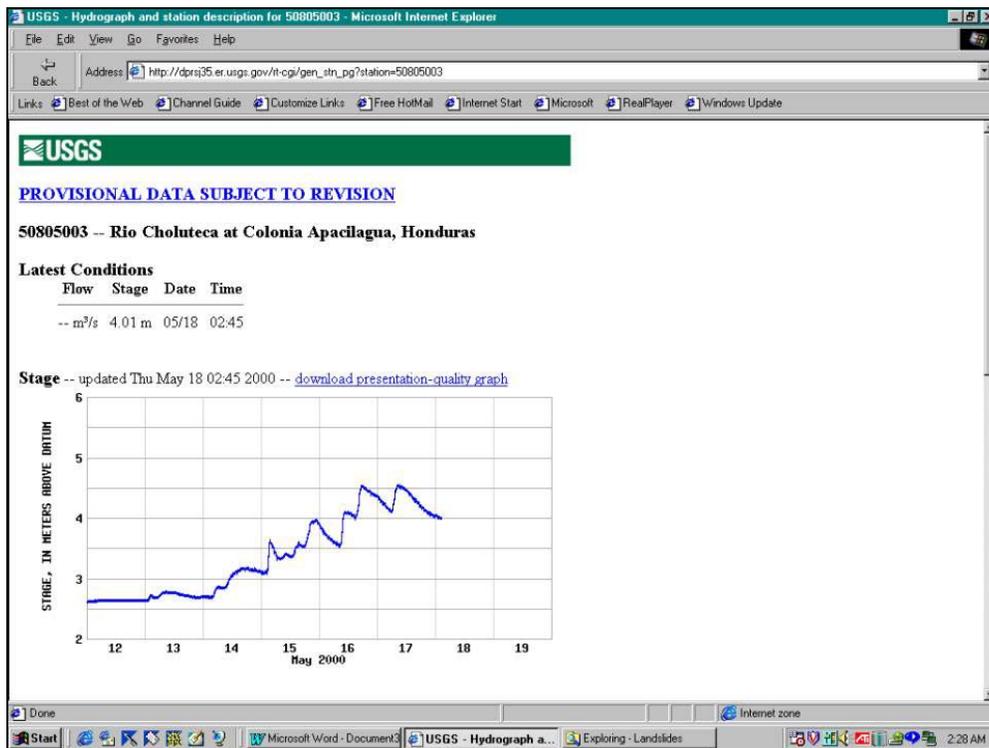
Hydrologic information recorded by each station is displayed in graphical and tabular for the previous seven days (fig. 3).

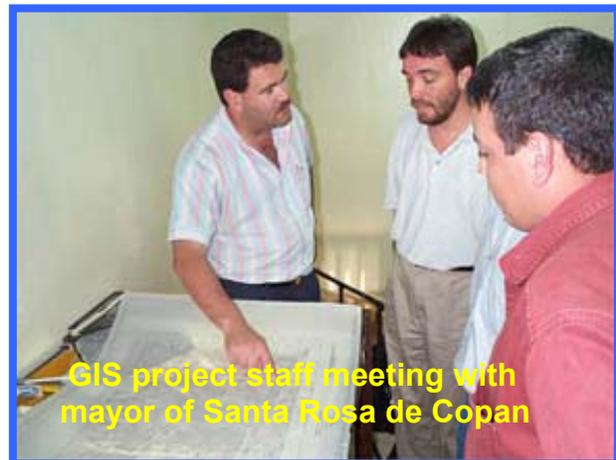
Left - Development of a cadastral database for tax assessment and tax-related information management.
