**Activities in Nicaragua
In Support of the
Hurricane Mitch
Reconstruction Program**

**A Final Report Submitted to
The U.S. Agency for International Development**

U.S. Geological Survey

May 2002

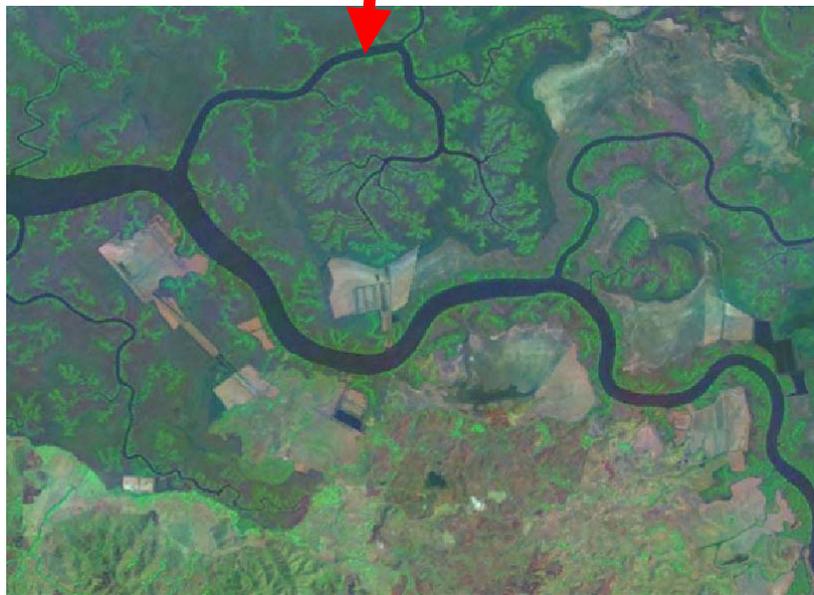
The sample Landsat image to the right shows the area around the Estero Real estuary, in western Nicaragua. Landsat mage products were provided to U.S. and Nicaraguan counterpart agencies participating in USAID-funded Hurricane Mitch relief activities, and are also now available to the public and private sector on a cost-of-reproduction basis. This imagery is being used for a wide variety of applications, including

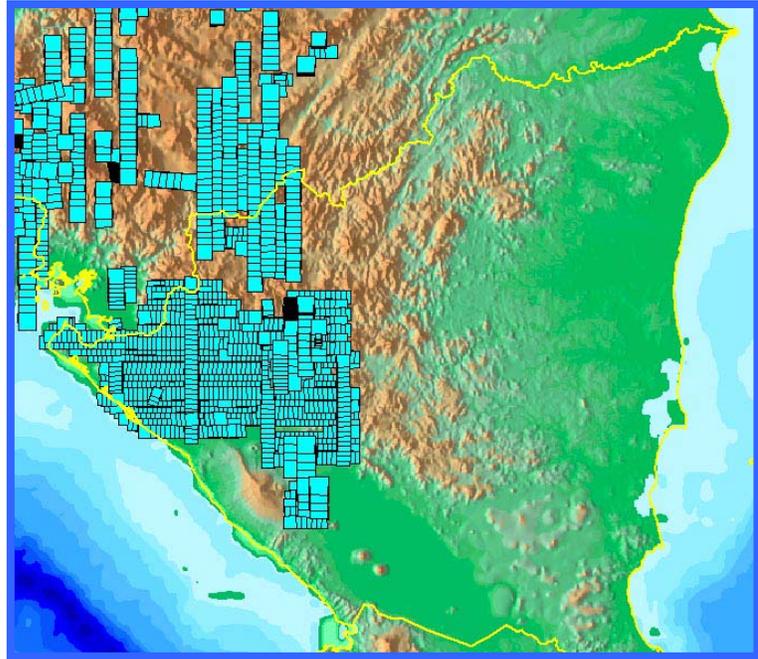
Aerial photography – The USGS acquired approximately 1700 frames of black and white aerial photography over Nicaragua (see figure to the right). This photography was utilized for fine-scale analysis and mapping of landslides and flood inundation patterns, and also provided the base for municipal information systems developed for 40 Honduran cities. All photography has been catalogued, indexed, and archived at USGS's EROS Data Center and is available to the public for the cost of reproduction.

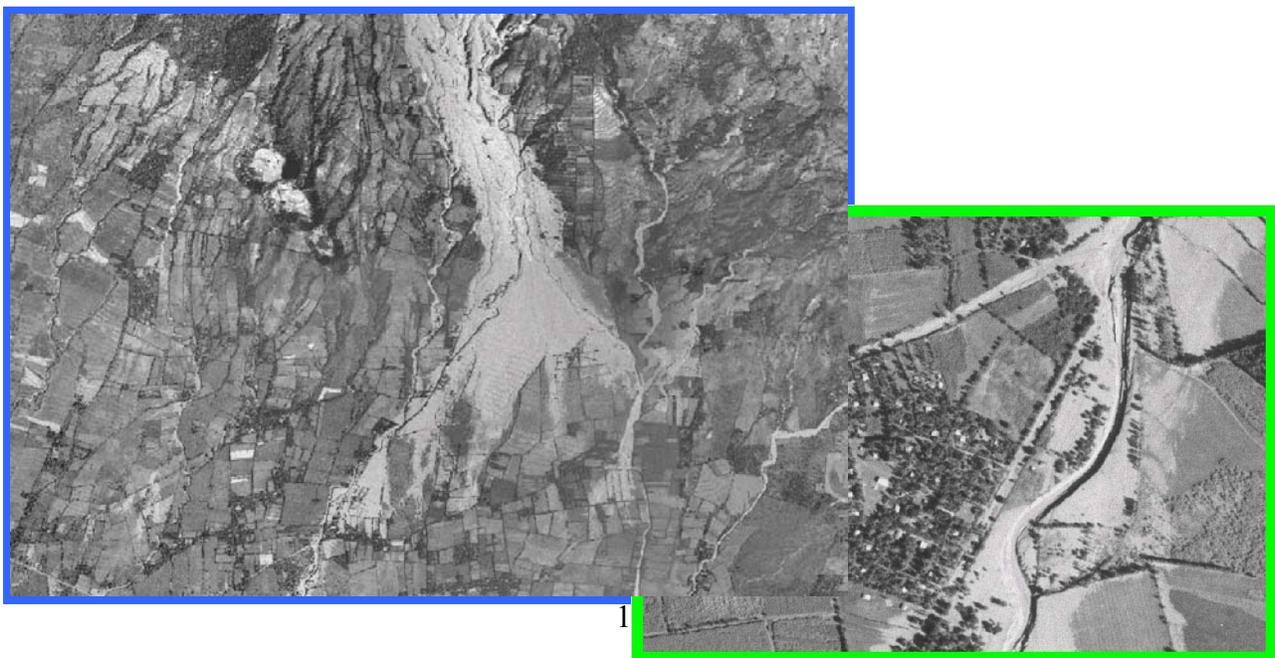
The aerial photos below were taken shortly after the catastrophic debris flow on the flanks of Casita Volcano, triggered by the intense rainfall during Hurricane Mitch. This event completely buried two towns and resulted in the deaths of over 2500 people. Photography like this was used in initial assessments of landslides and flooding throughout Nicaragua. Most of the aerial photography flown over Honduras was flown at a scale of 1:40,000, however high-resolution scanning of negatives produces images with resolutions of 2-3 feet, equivalent to much larger scale photography.

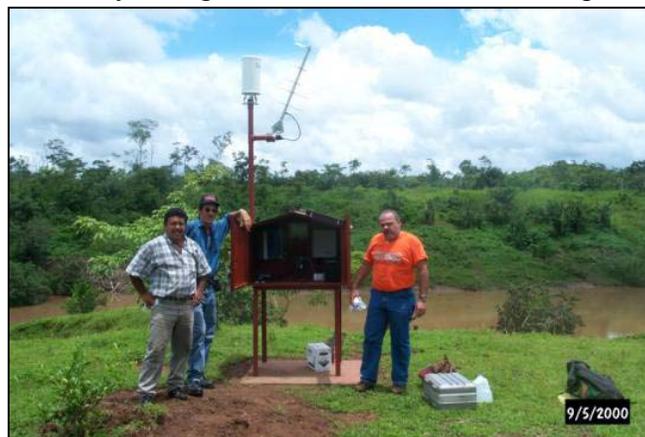
Figure 2. Streamflow monitoring station Río Siquia at Salto Grande.

Real-time transmission of data from hydrologic monitoring stations is new to Nicaragua – the technology implemented in Nicaragua is essentially the same as that used by the USGS in the United States. Each station transmits hydrologic data via satellite, which is received in real-time by downlink stations in Nicaragua and Puerto Rico. There are two modes of operation: 1) normal mode, in which hydrologic data collected every 15 minutes are transmitted via satellite at 3-hour intervals; and 2) emergency mode, in which hydrologic data are transmitted as frequently as every 5 minutes during periods of flooding or heavy rainfall. An example of the streamflow gaging stations installed as part of the program in Nicaragua is shown in 2. Table 1 at the end of this report a complete listing of hydrologic monitoring stations that were installed in Nicaragua.

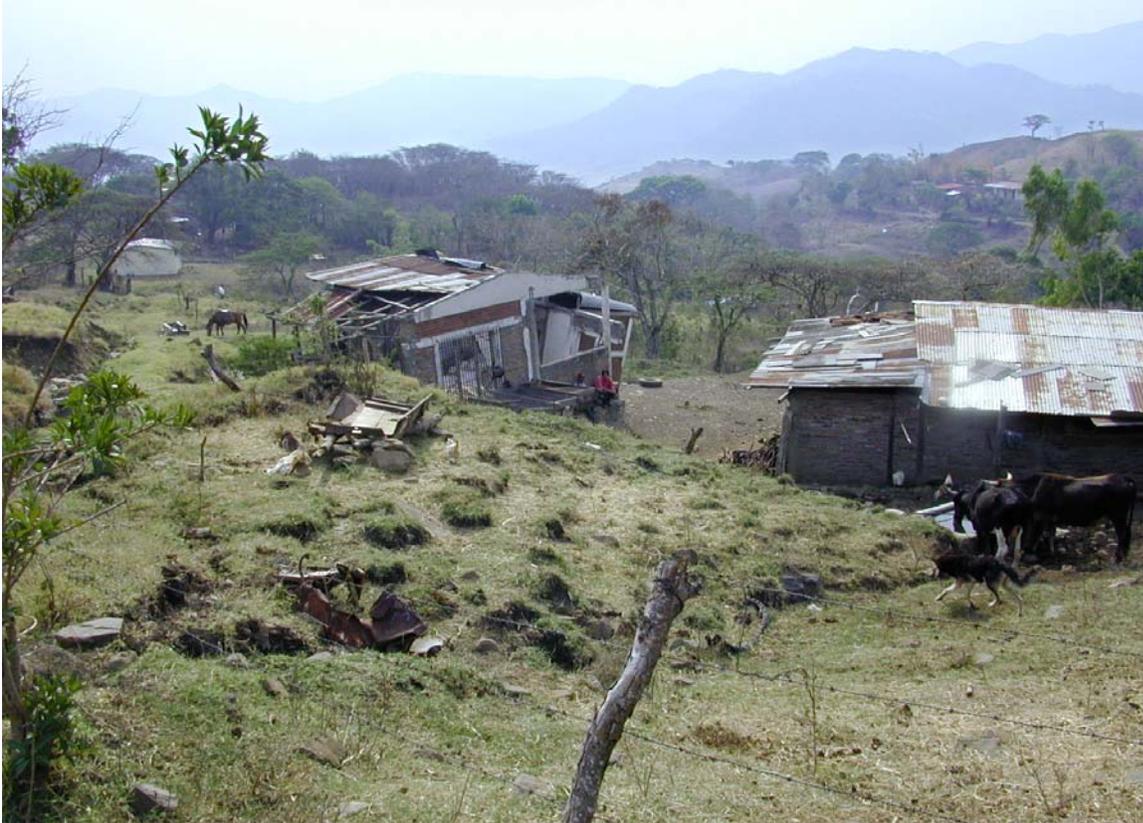
Figure 4.

Toe of the earth flow at San Simón de Palcila. House on the left was destroyed by movement on the earth flow. An active lobe of the earth flow is impinging on the house at the right.

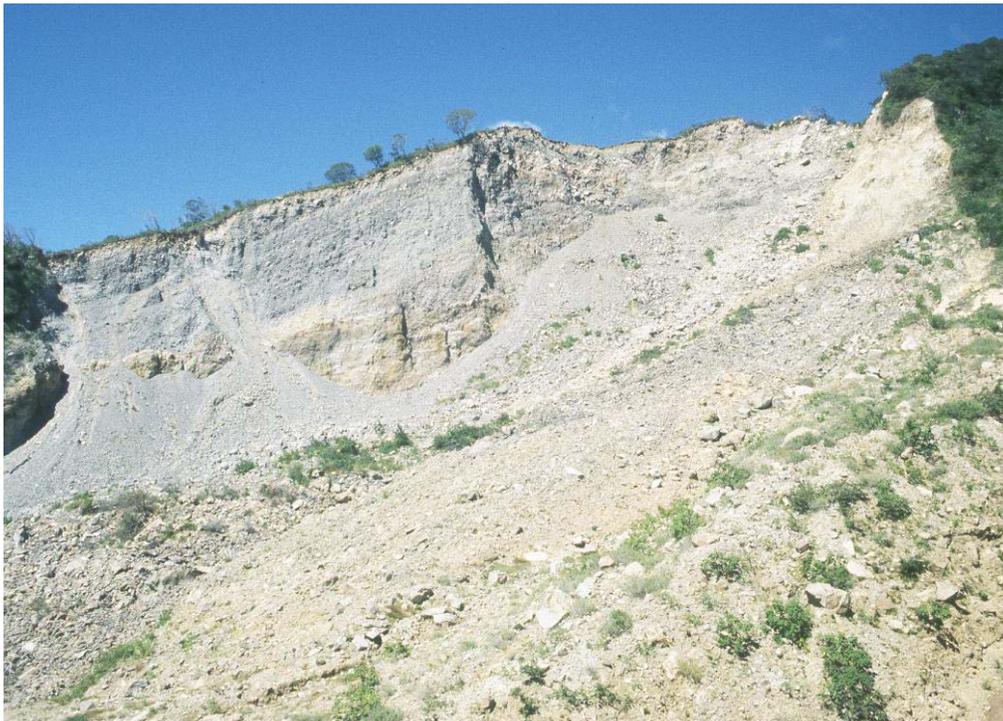
Figure 1. Photograph showing scarp and part of the avalanche of October 30, 1998 that occurred at Casita during Hurricane Mitch.

Particular objectives of the project were selected primarily in response to the disaster at Casita volcano, Nicaragua. At Casita, Hurricane Mitch triggered a 1.6-million-cubic-meter landslide that transformed into a rapidly moving debris flow that destroyed two villages and killed about 2500 people (Figures 1 and 2). If field investigations and lahar-hazard analyses had been conducted at Casita volcano prior to Hurricane Mitch, they would have shown that the towns destroyed were located in an active lahar pathway that was extremely hazardous (Figure 2). Experience at other volcanoes worldwide shows that population centers and infrastructure located near volcanoes are at risk from a variety of hazardous events--both related and unrelated

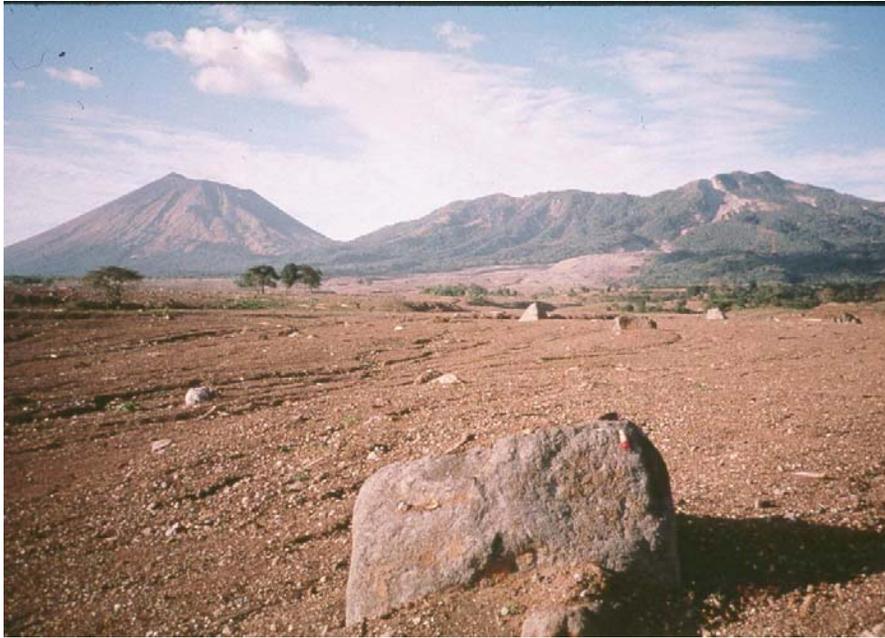
Figure 2. Photograph showing the devastation of the Casita lahar from a site near the two destroyed towns of El Porvenir and Rolando Rodriguez.
