Toe of Campo Cielo Landslide that has Engulfed a Road in the Community

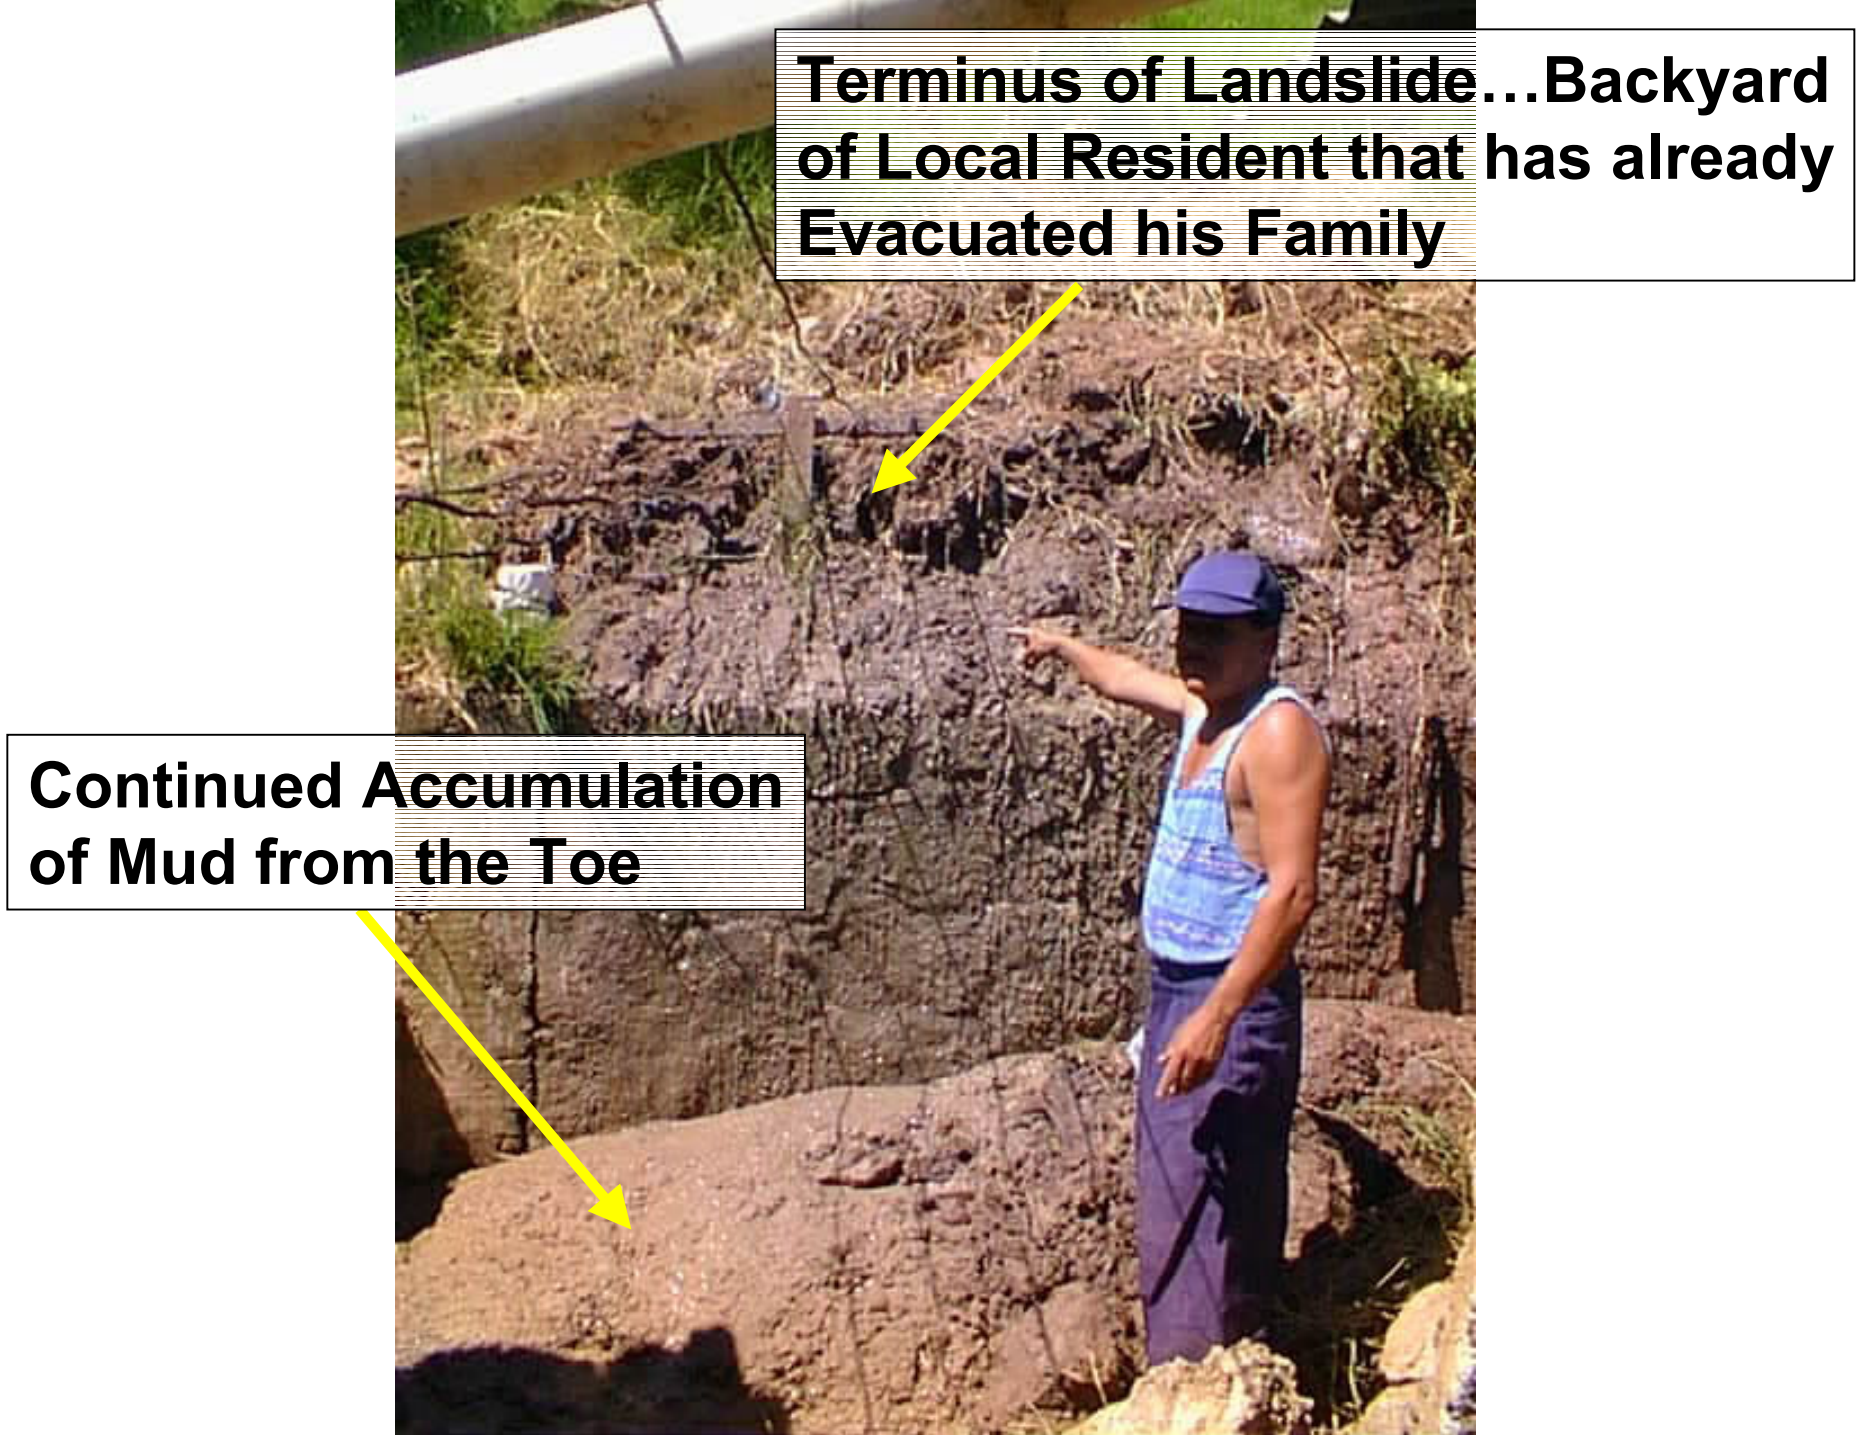
Recently Formed Fractures at the Landslide Toe
